## ENVIRONMENTAL IMPACT ASSESSMENT

# Restoration of the Masaorambhu Stream

*Desilting & Reconstruction of Seven Check Dams*

Masaorambhu Stream,  
Siruvani, Coimbatore

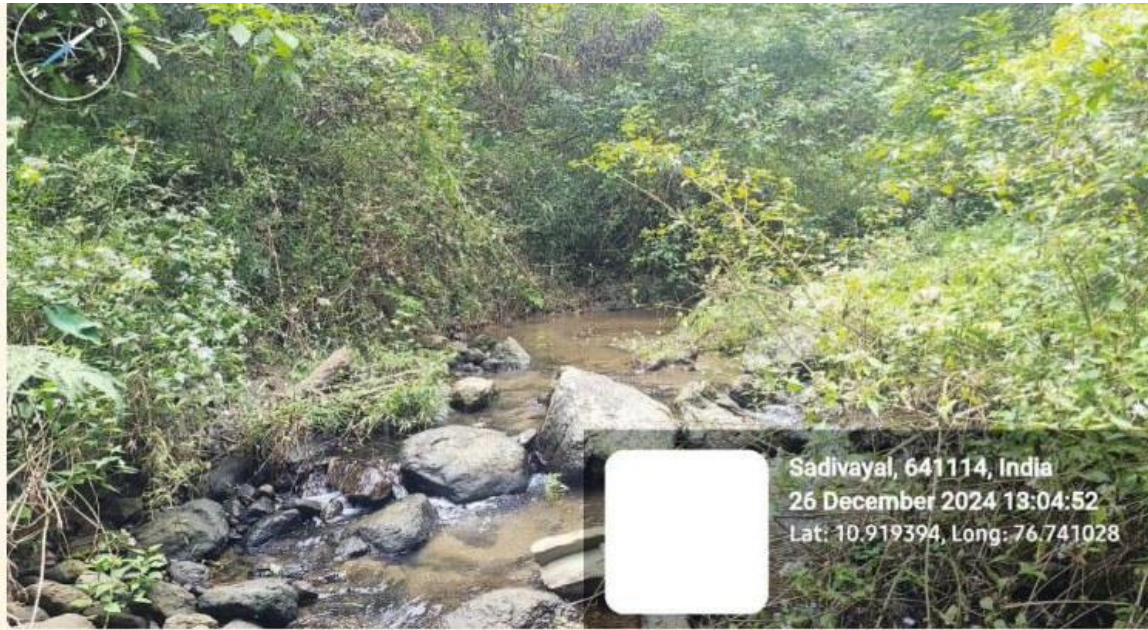
*Inlet of the Masaorambhu Stream at the border of Reserve Forest and Patta land (Dec 2024)*

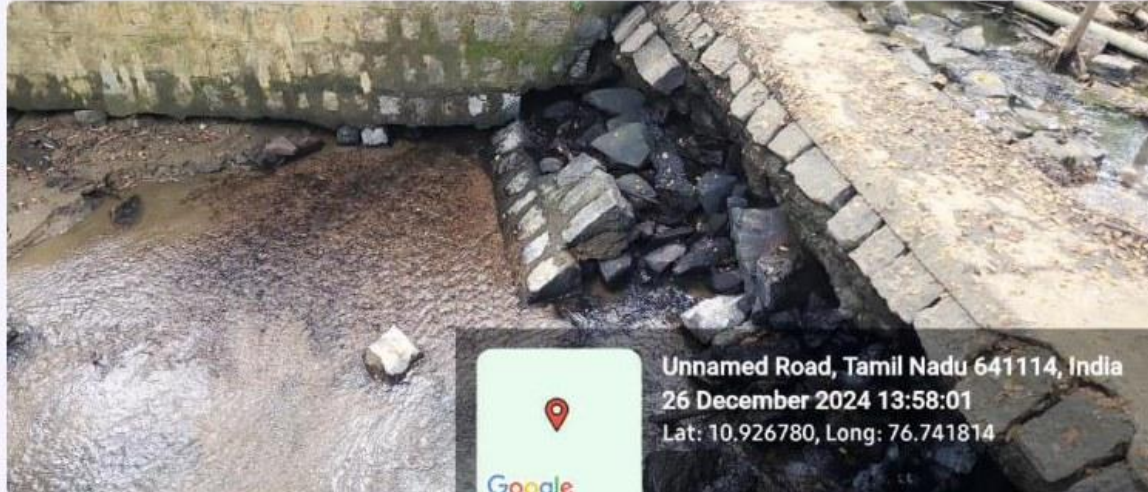
Severe damage to a weir wall leading to water seepage — baseline condition (Dec 2024)

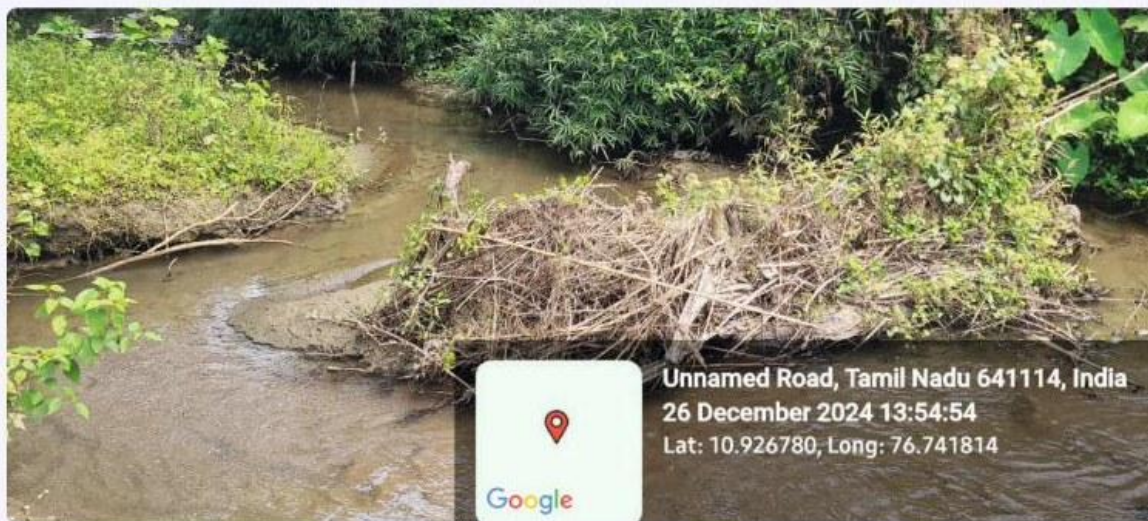
Severe silt formation and vegetation obstructing water flow — pre-intervention

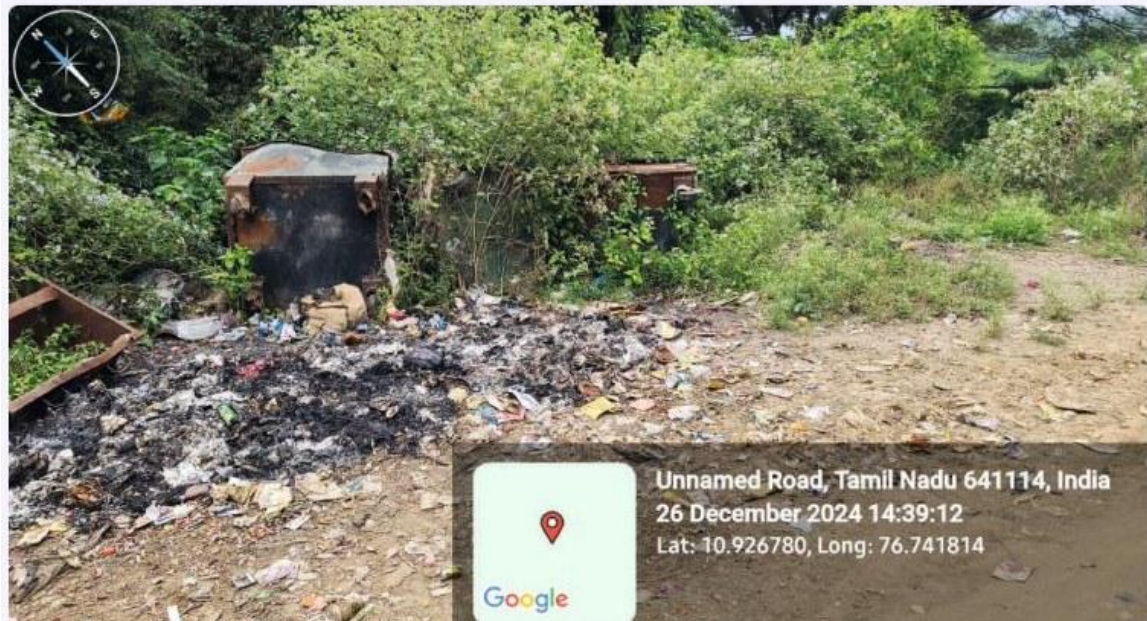
During field inspections, localised dumping of solid waste was observed in areas near Check Dam 6. The waste consisted primarily of household refuse and construction debris disposed along the stream banks. Improper disposal of waste in riparian areas poses several environmental risks, including potential contamination of surface water during rainfall runoff, obstruction of stream flow and drainage pathways, and degradation of habitat conditions for aquatic and riparian species.

*Waste dumping into the stream and bunds by community near Check Dam #6*

Panchayat has taken actions to address this by introducing daily home collection of waste by green friends. This is making a change in the waste dumping practices alongside the Check dam/ stream

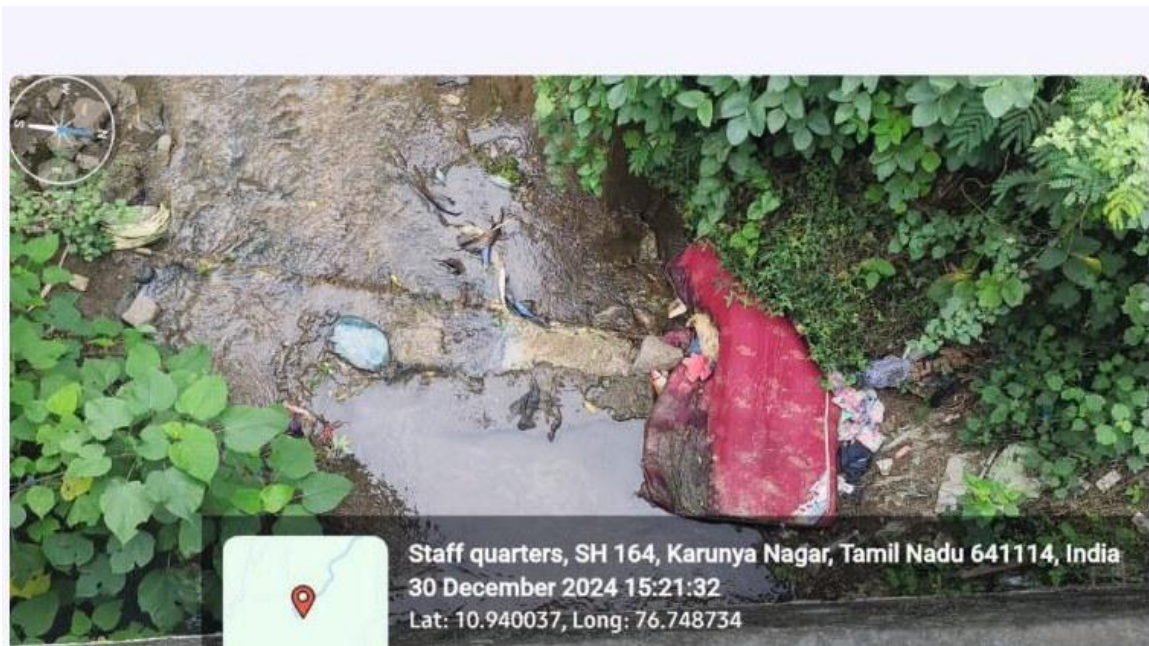
Another environmental concern identified during the assessment is the presence of untreated or partially treated wastewater entering the stream near the Siruvani Road section. Sewage inflow into natural water bodies can lead to nutrient enrichment and eutrophication, reduction in dissolved oxygen levels, and degradation of water quality for downstream users. While the current impact on water quality appears limited due to dilution during rainfall events, continued discharge may gradually affect ecological health. Installation of appropriate sewage treatment systems would significantly reduce this risk.

*Sewage discharge observed near the Siruvani road section*

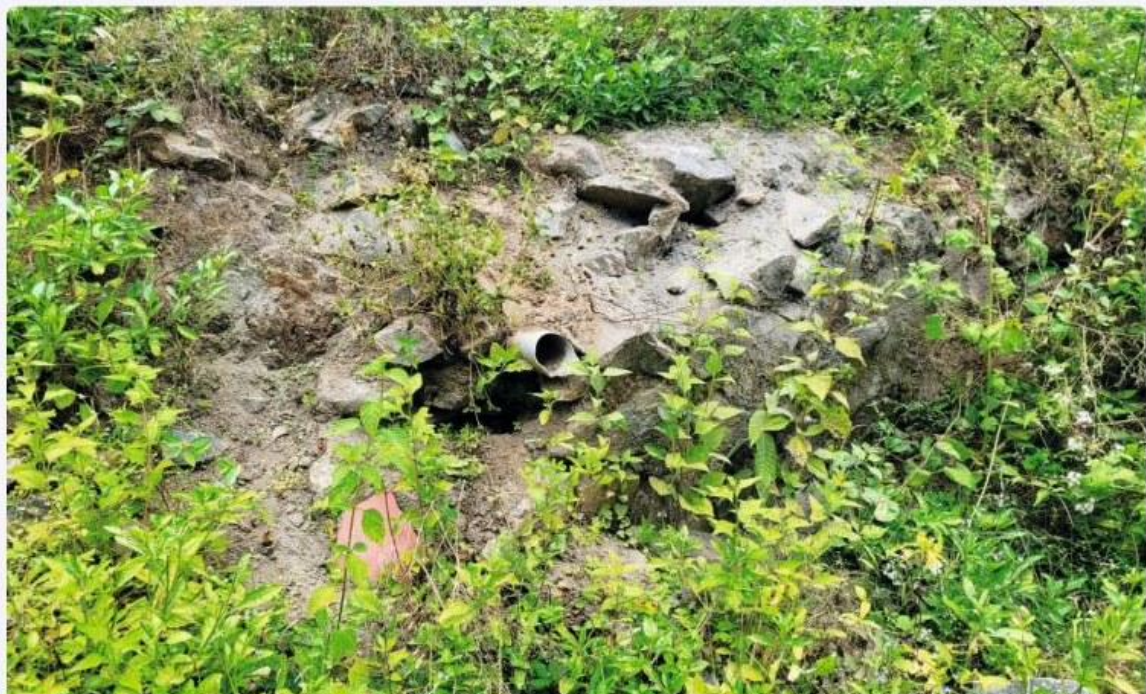
The assessment noted the potential discharge of wastewater from nearby educational and institutional campuses located within the broader watershed. While these institutions maintain internal wastewater management systems, ensuring that only properly treated water is released into the natural drainage system is essential to prevent contamination of the stream. Institutional collaboration and environmental compliance will therefore play an important role in safeguarding the restored stream ecosystem.

*Outlet pipe from a nearby institutional campus discharging into the stream*

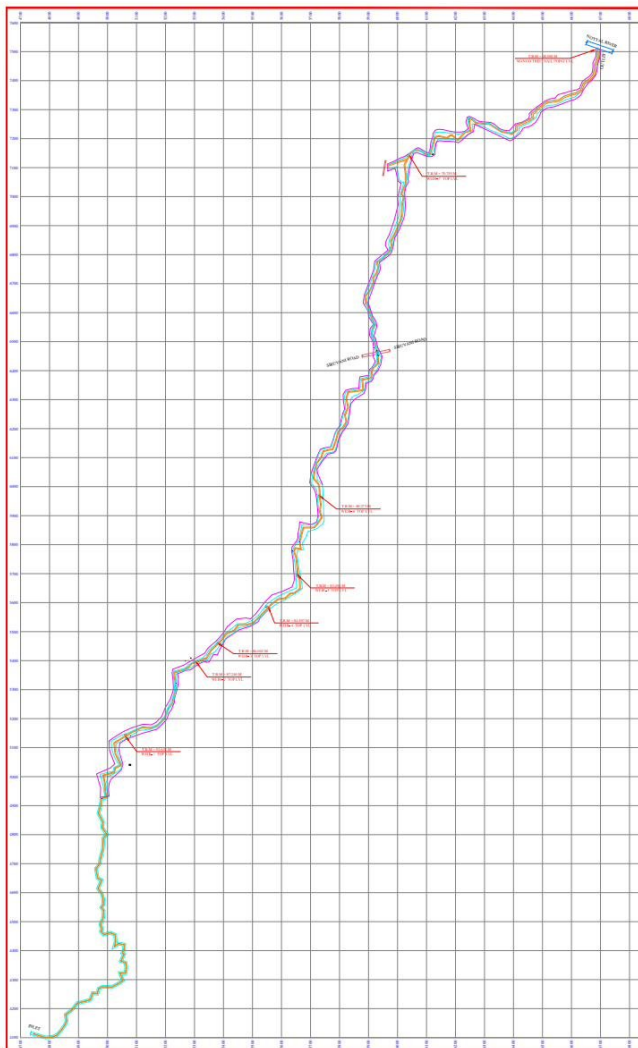
Stream profile prior to intervention — Dec 2024

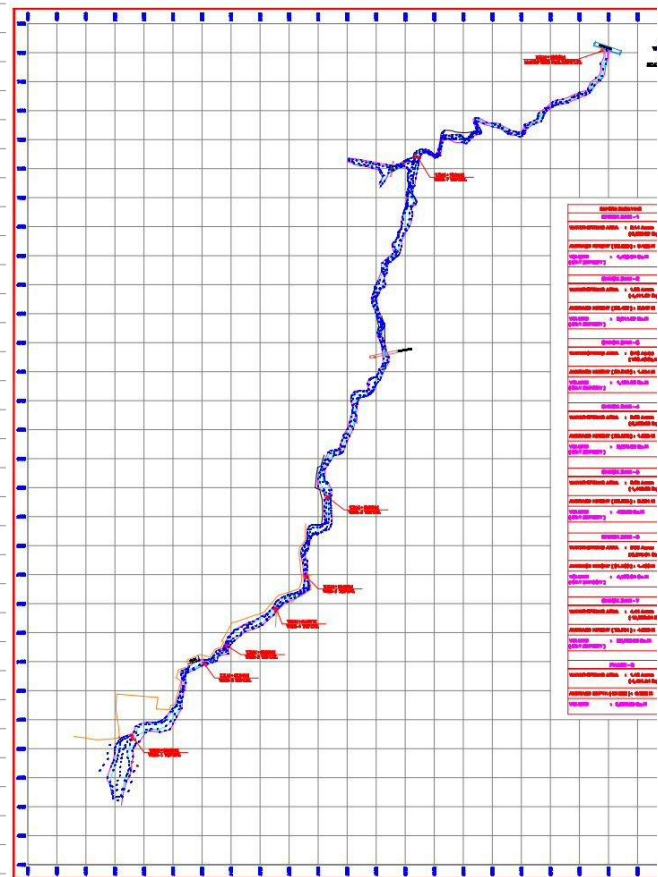
Stream profile post-restoration — 2025/2026

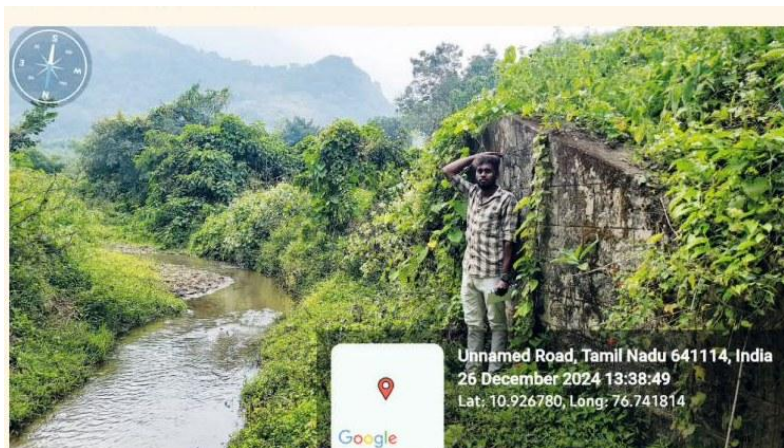
Check Dam #1 — only wing walls and no weir wall at baseline (Dec 2024). Water flow width of just 5–8 feet and no storage area.

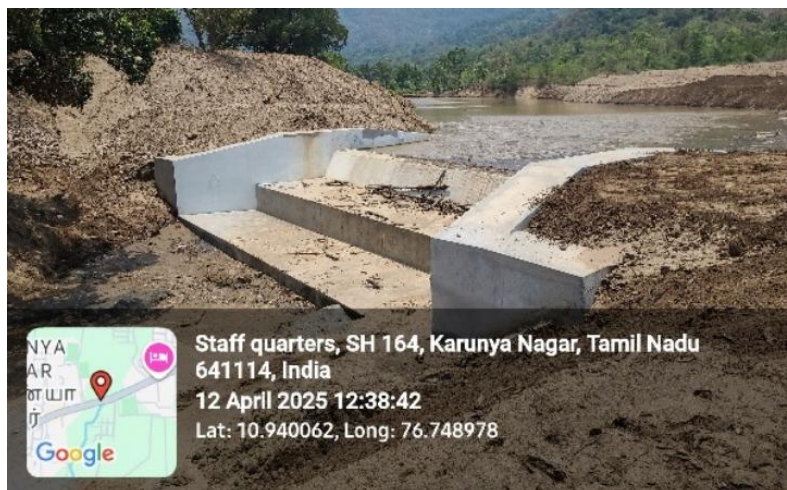
Check dam #1 with reconstructed Check dam and huge water storage area

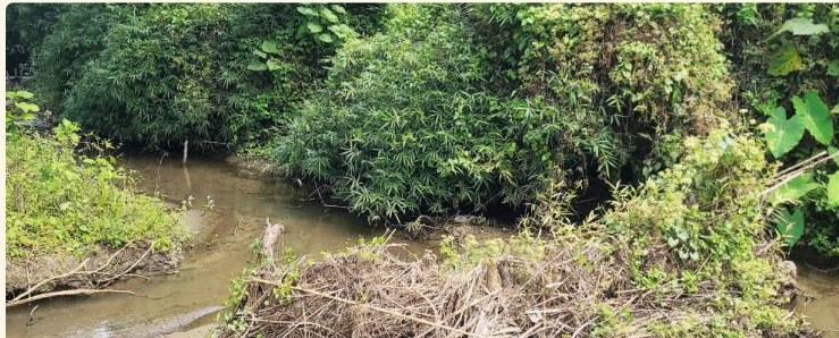
Check Dam #2 — only wing walls and no weir wall at baseline.

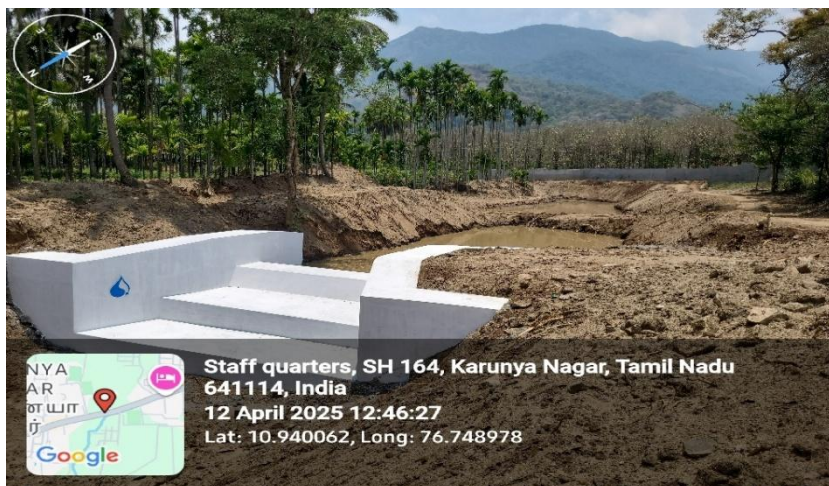
Reconstructed Check dam #2 and desilting is complete

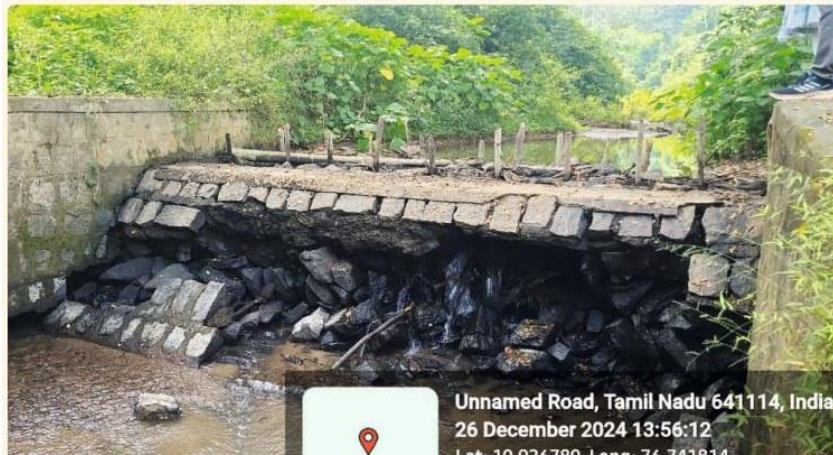
Check Dam #3 — severe silt accumulation, cracks and seepage in the weir; almost inaccessible at baseline.

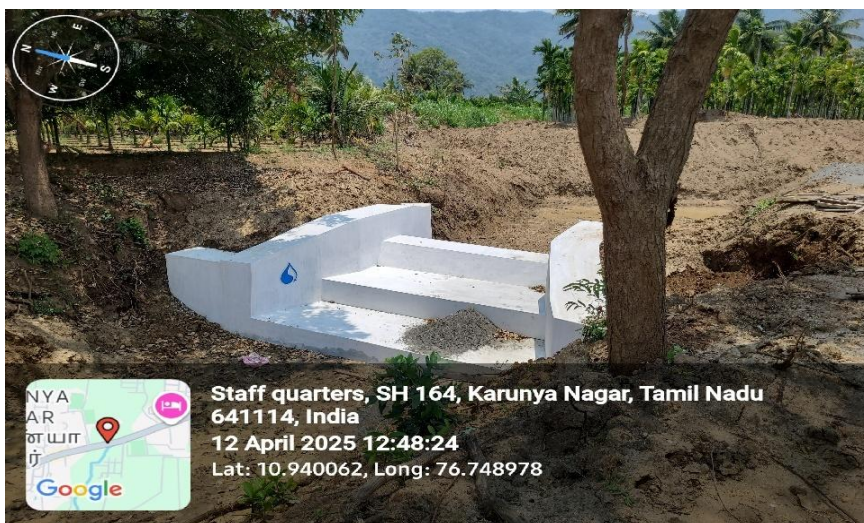
Check dam #3 after reconstruction and desilting

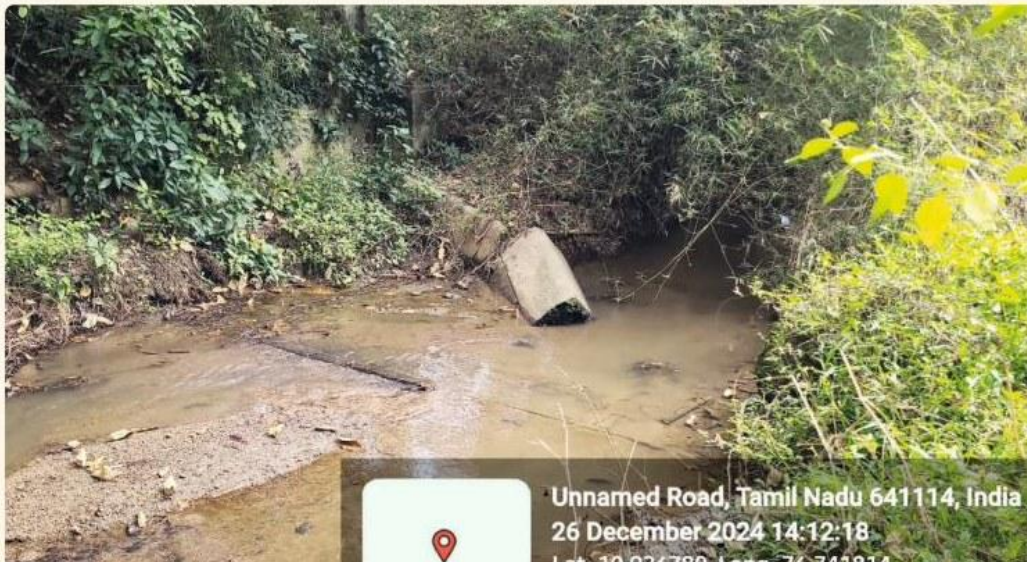
Check Dam #4 — only wing walls and no weir wall at baseline.

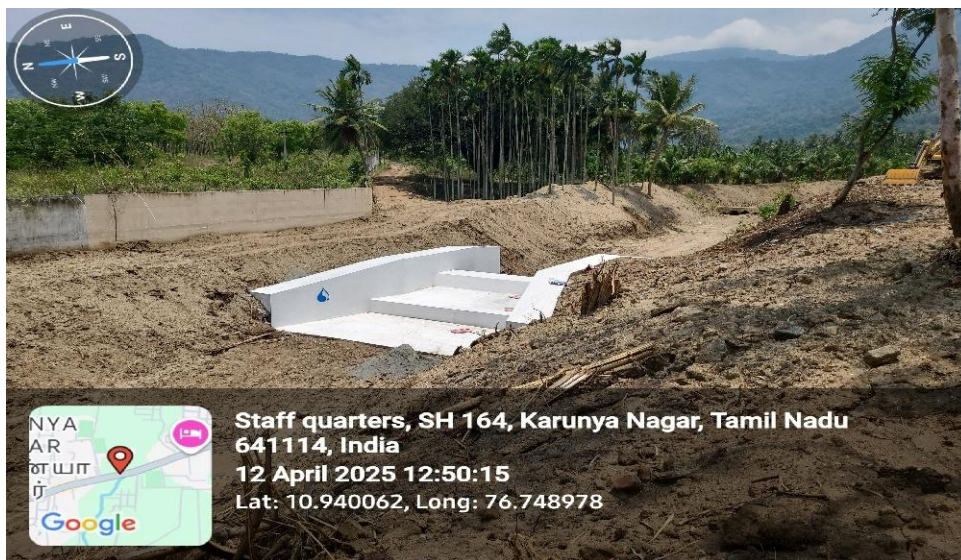
Check dam #4 after reconstruction and desilting

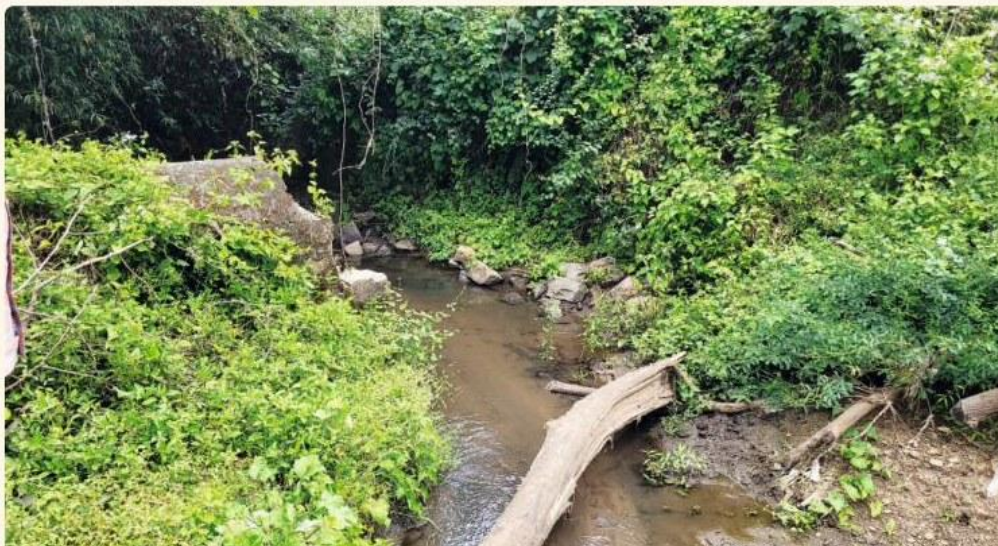
Check Dam #5 — only wing walls and no weir wall at baseline.

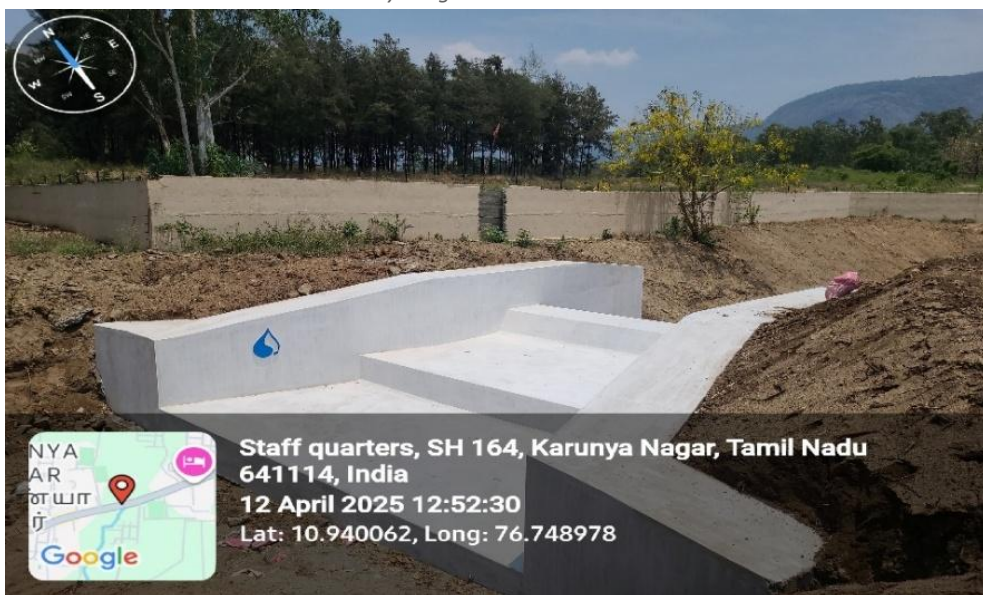
Check dam #5 after reconstruction and desilting

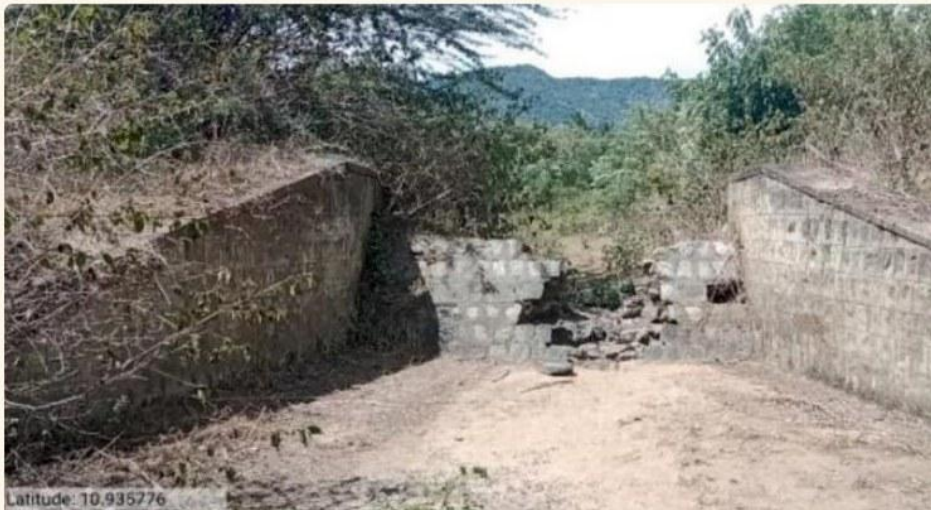
Check Dam #6 — only wing walls and severe damage to weir wall at baseline.

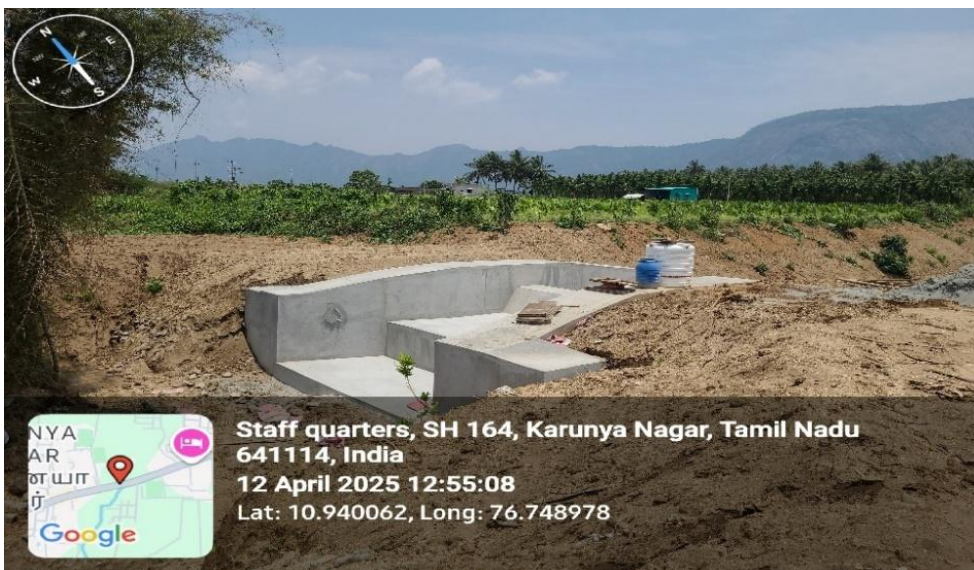
Check dam #6 after reconstruction and desilting

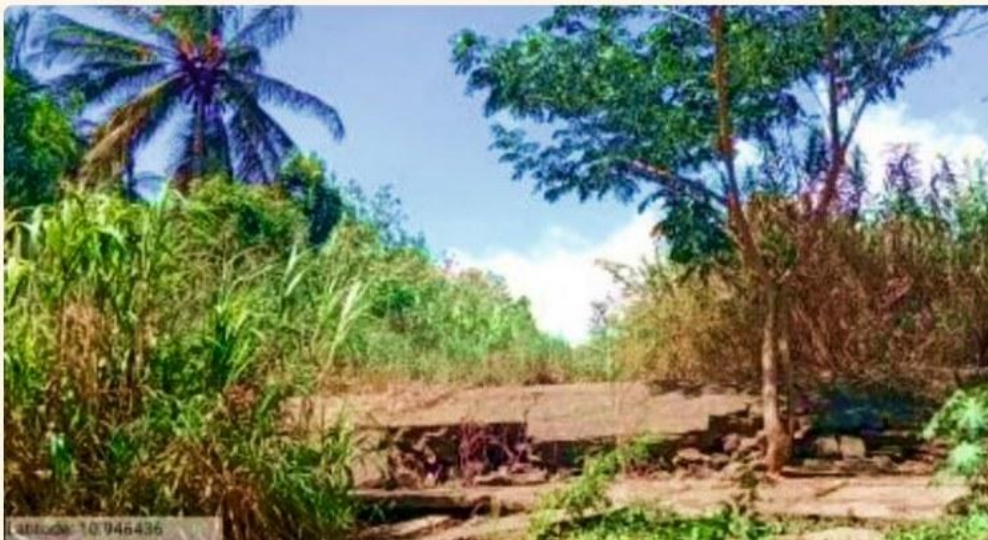
Check Dam #7 — no wing walls and no weir wall at baseline; the largest silt removal on the corridor.
