# Environmental Audit Report

## Post Restoration of Gunduperumbedu Lake

May 2026

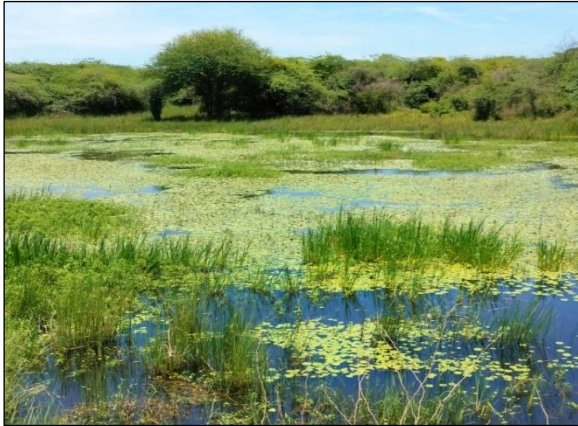
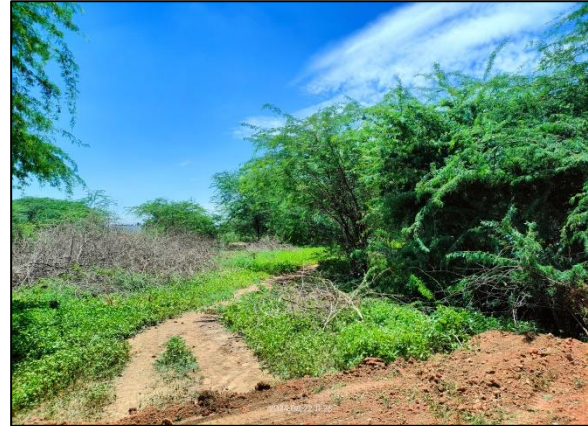
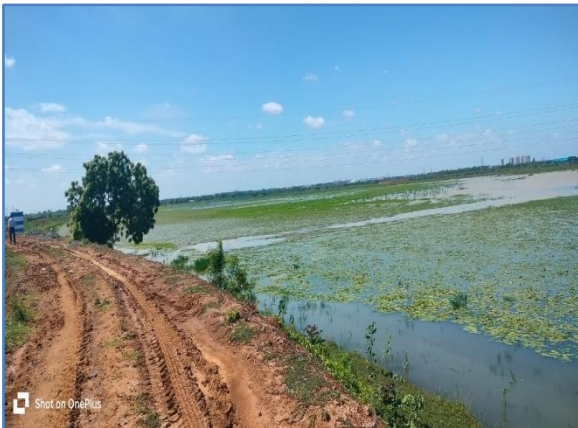
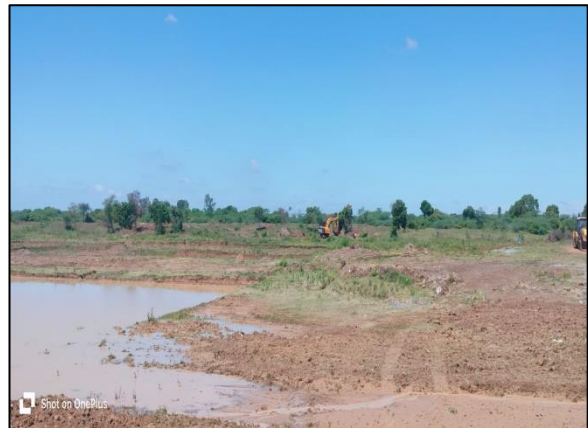
The lake bund was infested with invasive mesquites and the water was overrun with aquatic weeds prior to restoration. As a part of the restoration activities, de-weeding of both the lake and the bund has been done. The removed weeds have either been composted or safely buried. The photographs of the lake and its surrounding areas before restoration and after restoration are in Figure 2.3

**2.3 a): Lake and its surrounding invested with weeds before restoration**

**2.3 b): Lake and its surrounding post de-weeding**

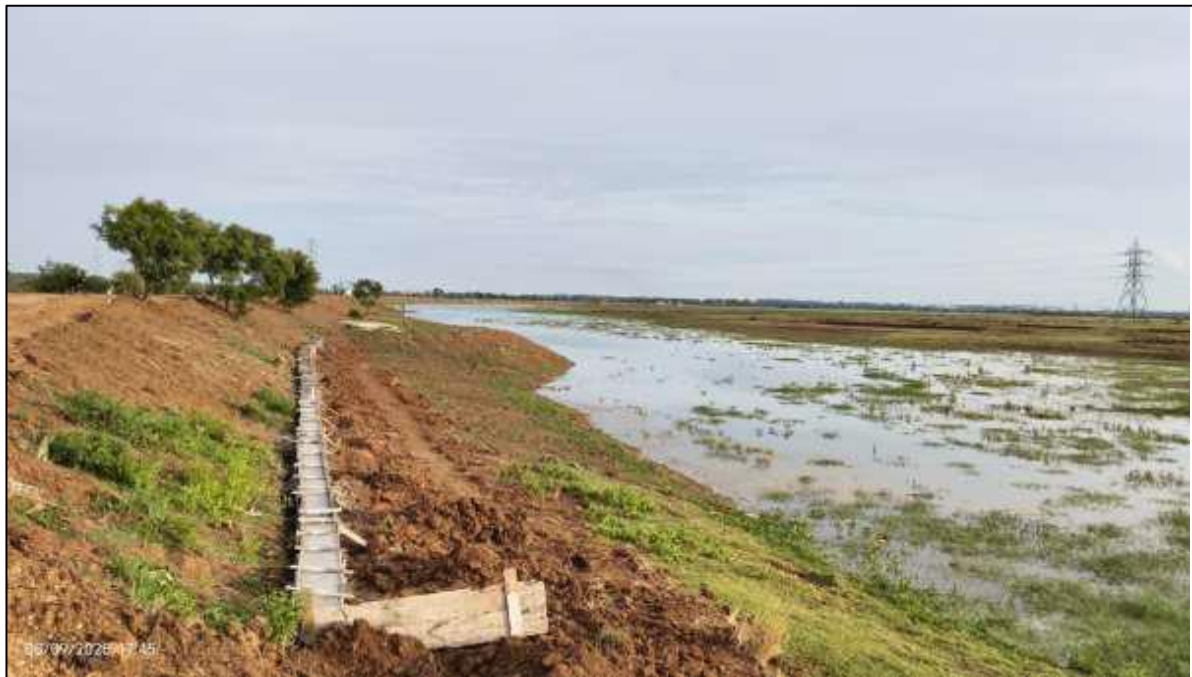
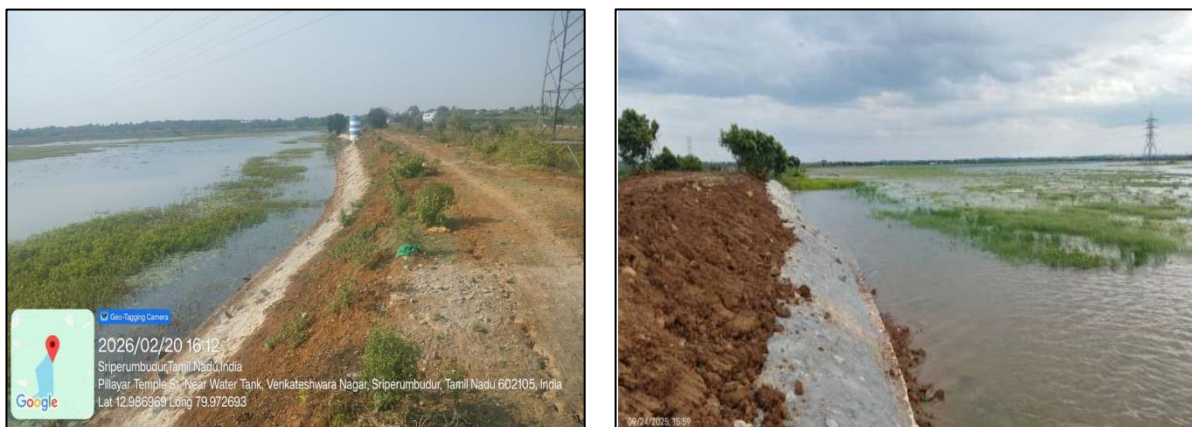
**Stone Pitching:** Large aggregates have been laid in a staggered pattern with mortar pointing to strengthen the embankment and protect it from erosion. However, the quality of the work does not appear to be good. In many spots the aggregates have fallen and the base wall of the sluice gates are broken. Photographs of the toe wall and the stone pitching carried out are shown in Figure 2.5.

**Figure 2.5 a): Toe wall constructed at the base of the Bund**

**Figure 2.5 b): Stone pitching done near the sluice gates and weir**

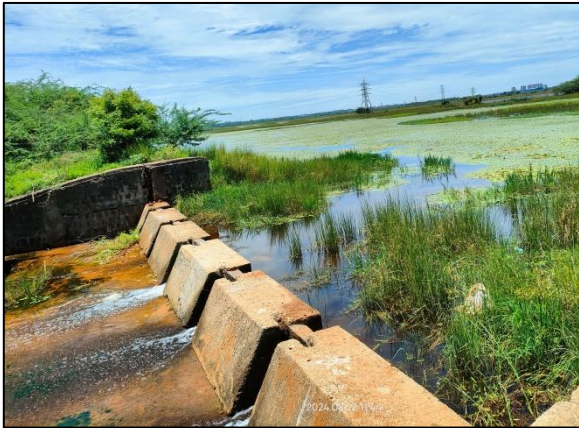
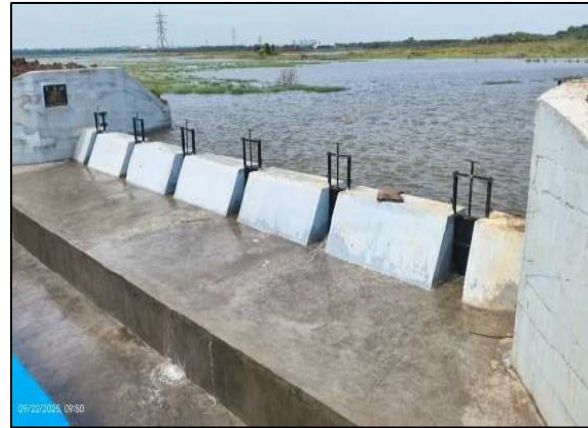
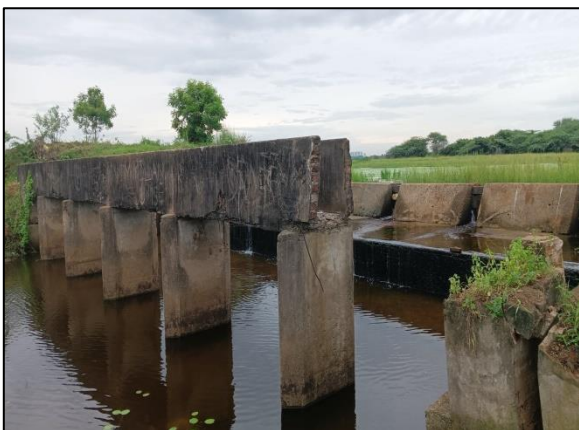
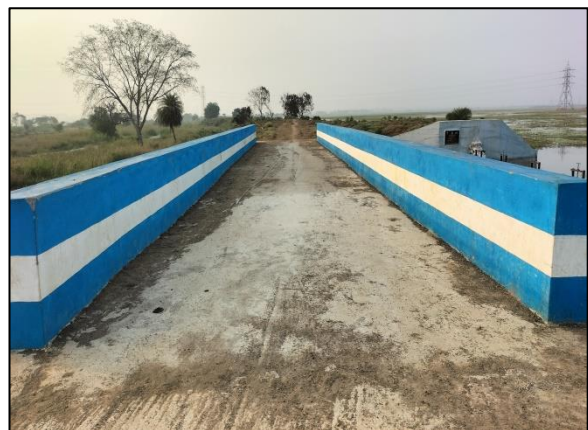
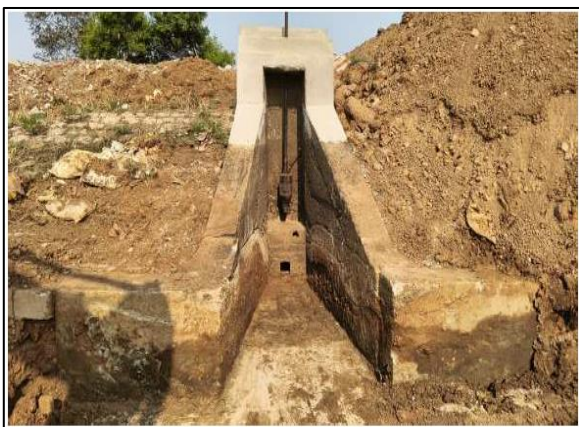
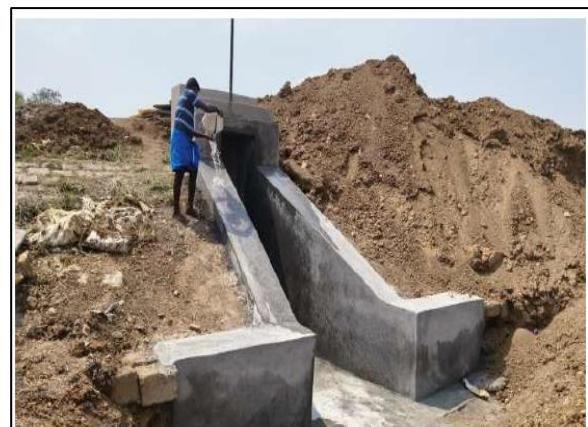
**Figure 2.7: Photographs of the tank structures before and after restoration**

An RCC walkway at the northern end of the lake, which provides access to the sluice gates, was found to be damaged requiring urgent attention. The surplus weir and the walkway have been renovated, thereby restoring access to the lake and the sluice gates. De-weeding, de-silting and removal of invasive plant species have also been carried out. Additionally, two mud mounds have been built in the lake, probably to enhance the aesthetic value and ecological features. No appreciable benefits of these structures were visible during the field study.

Routine inspection of tank structures and channels shall be conducted to identify maintenance needs and prevent potential structural failures.	<b>Not Implemented</b> - The tank structures were found to be damaged highlighting poor quality of civil work. Stone pitching along the bund has fallen off in some locations. These observations highlight the need for routine inspection and preventive maintenance.
	Formation of local committees for participatory lake management and decision-making	<b>Implemented</b> - A lake management committee is formed to oversee lake management activities. However, a clear SOP on Community participation and institutional framework shall be provided for effective management and decision making.
	Monitoring of benefits such as agricultural productivity, livelihood improvement and community satisfaction	The actual benefits of the restoration with respect to agricultural productivity require at least one additional year of monitoring to generate reliable data on crop yield from the farmers during both the cropping seasons post-restoration.

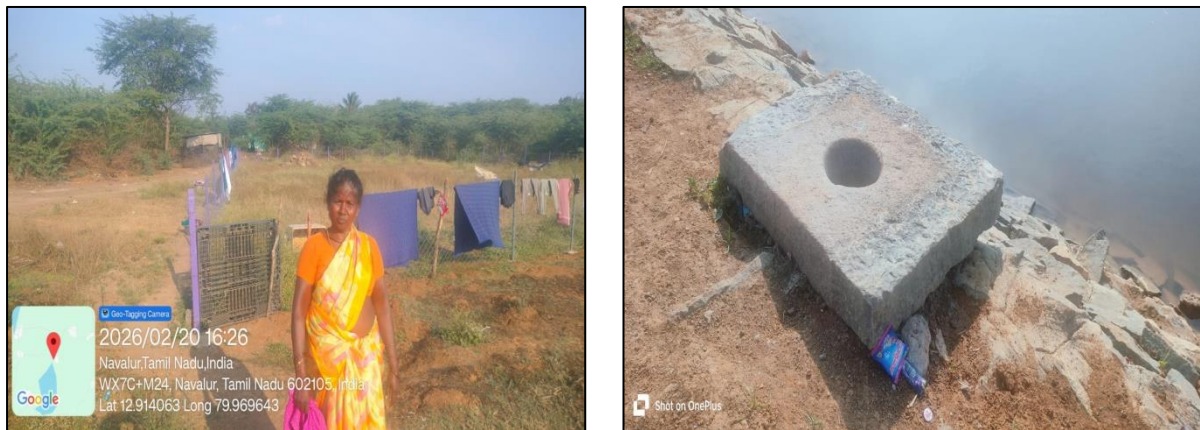
**Figure 3.7: Photographs of washing activities observed in the lake**

Activities such as clothes washing, bathing and livestock washing were observed, contributing to increased coliform levels and potential contamination.

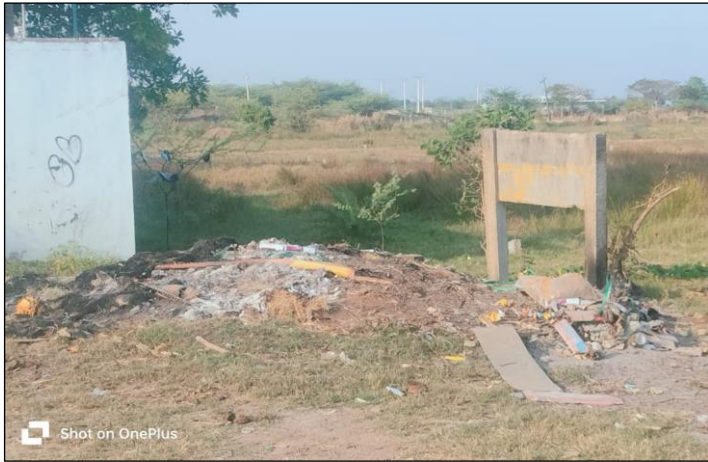
<b>Figure 4.1: Photographs of Open Burning near industrial areas</b>
	Adoption of phased approach for de-silting and de-weeding to minimize	<b>Implemented</b> - De-silting has been carried out by excavating 122 pits measuring 50 m length, 30 m breadth and 0.6 m depth.

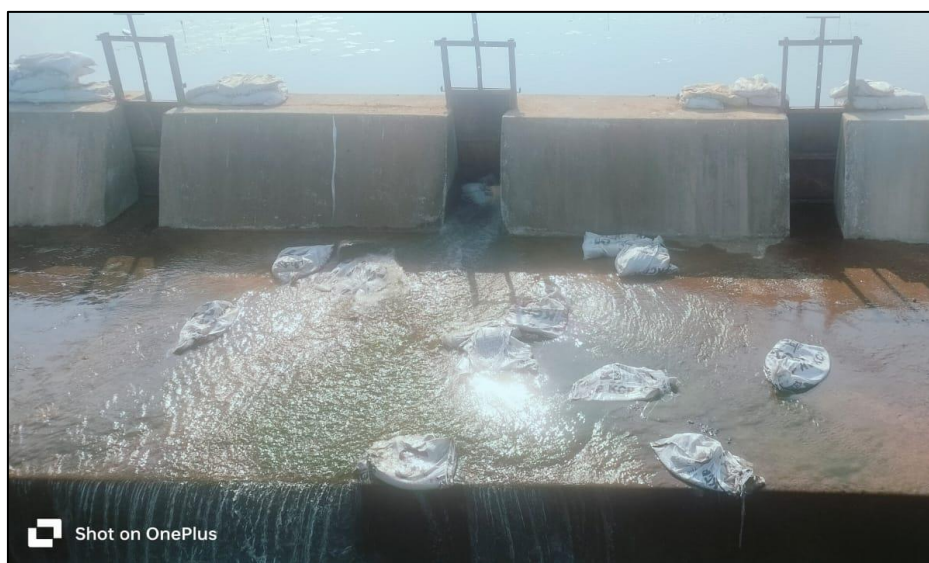
Sluice gates were found to be rusted and not fully functional. Use of sand filled bags (Figure 4.4) for regulating water flow was observed.

**Figure 4.4: Photograph showing use of sand filled bags to regulate water flow**
