# Environmental Audit Report

## Post Restoration of Gunduperumbedu Lake

July 2026

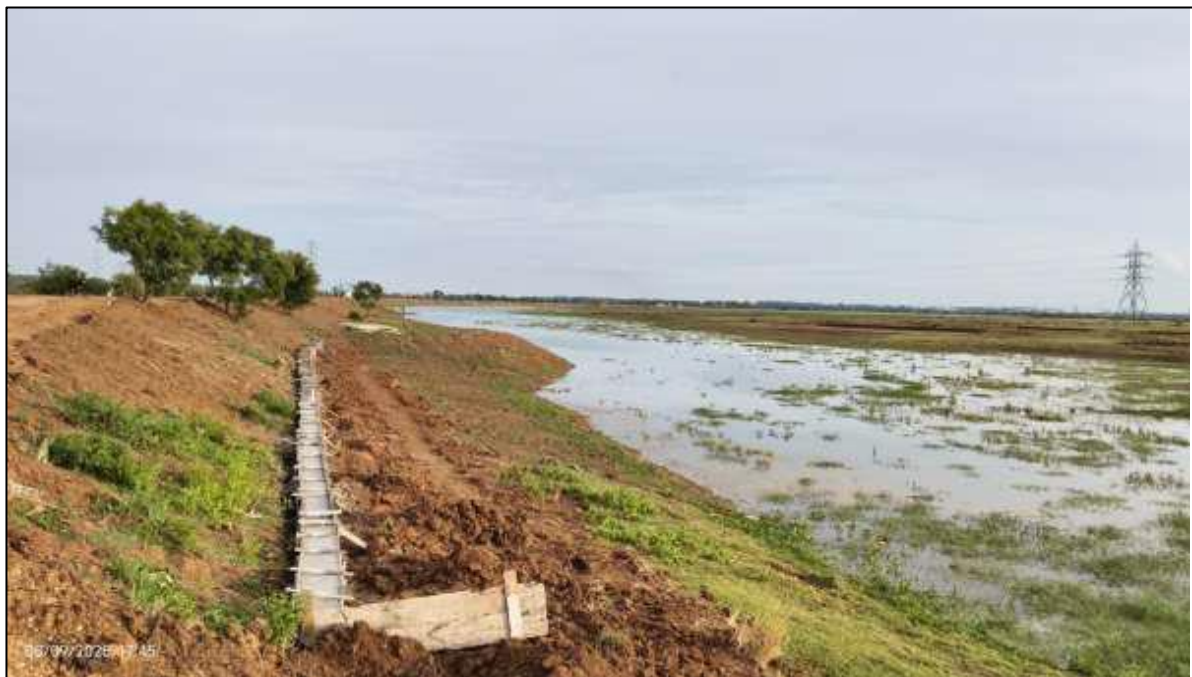
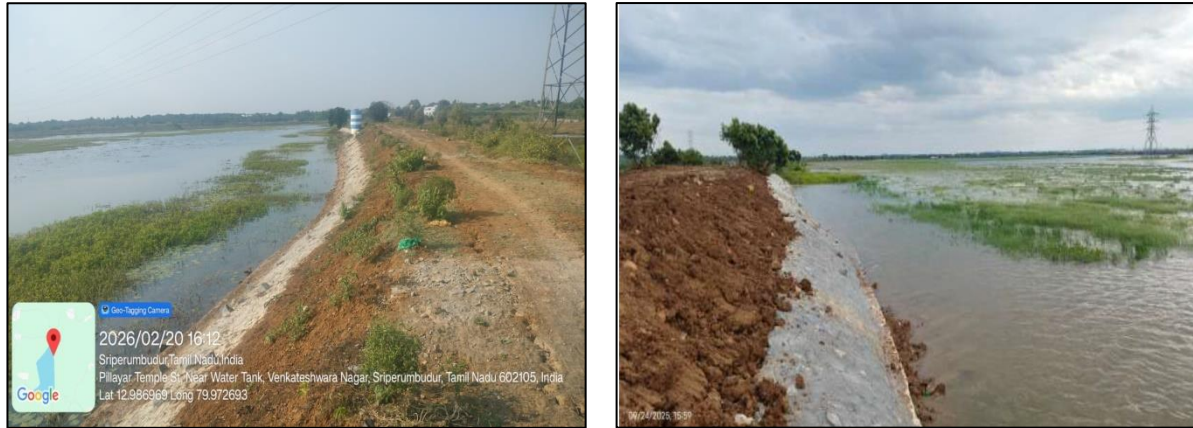
**Stone Pitching:** Large aggregates have been laid in a staggered pattern with mortar pointing to strengthen the embankment and protect it from erosion. However, the quality of the work does not appear to be good. In many spots the aggregates have fallen and the base wall of the sluice gates are broken. Photographs of the toe wall and the stone pitching carried out are shown in Figure 2.5.

**Figure 2.5 a): Toe wall constructed at the base of the Bund**

**Figure 2.5 b): Stone pitching done near the sluice gates and weir**

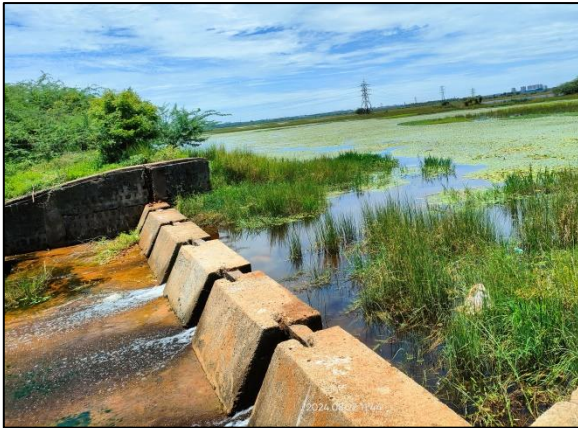
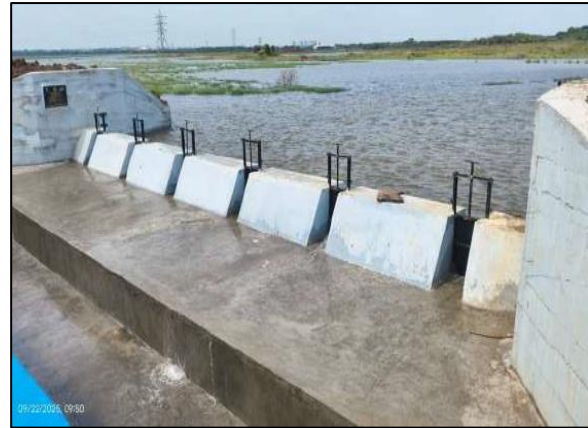
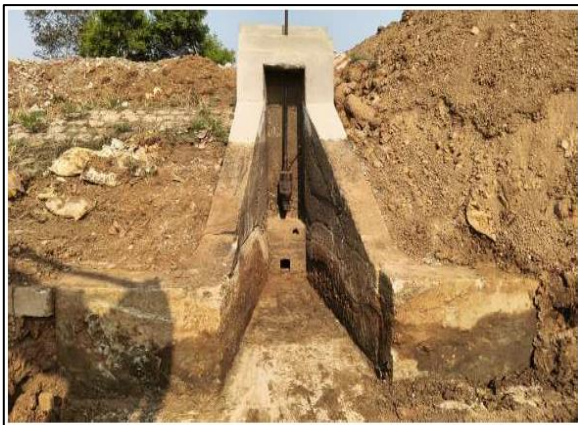
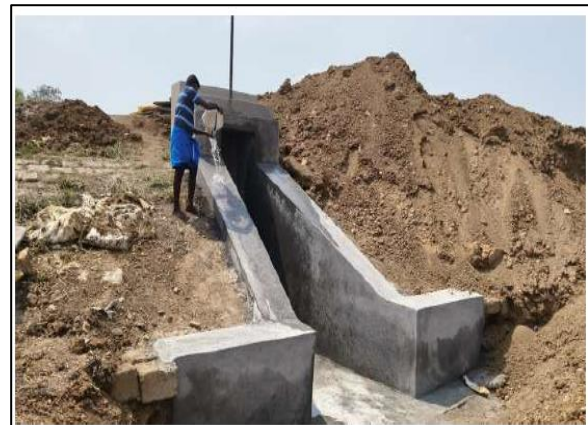
**Weir before restoration**

**Weir after restoration**

**Sluice gate before restoration**

**Sluice gate after restoration****Figure 2.7: Photographs of the lake structures before and after restoration****2.2.4 Access to the Lake**

An RCC walkway at the northern end of the lake, which provides access to the sluice gates, was found to be damaged requiring urgent attention. The surplus weir and the walkway have been renovated, thereby restoring access to the lake and the sluice gates. De-weeding, de-silting and removal of invasive plant species have also been

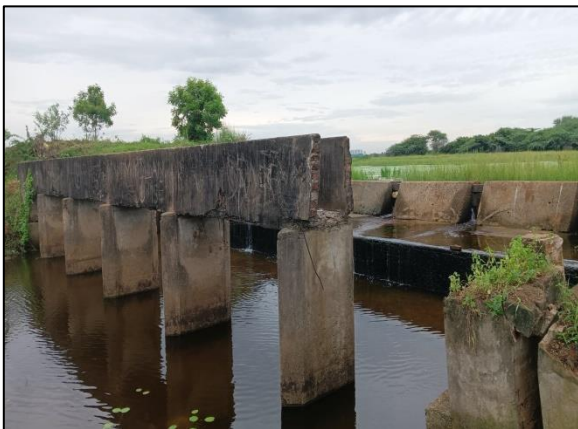
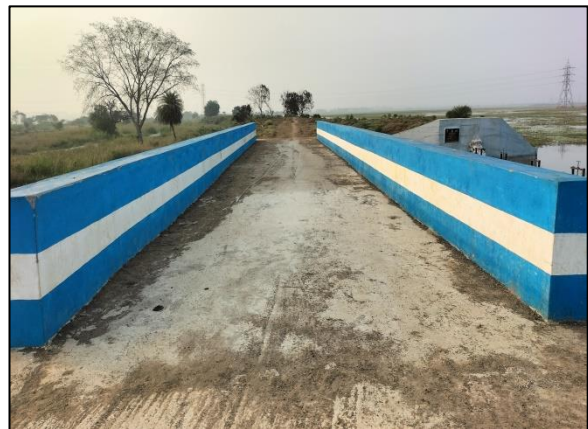
**Walkway before restoration**

**Walkway after restoration**

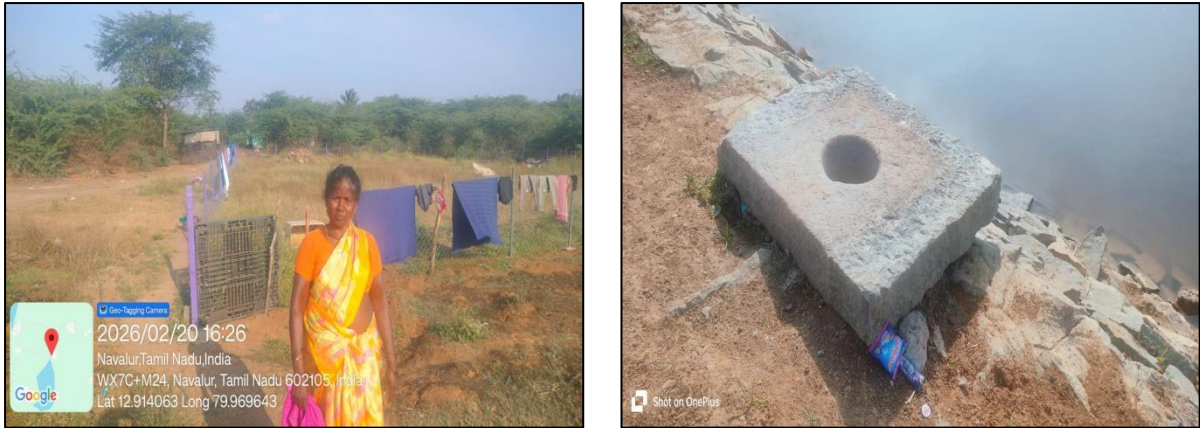
**Figure 3.9: Photographs of washing activities observed in the lake**

Activities such as clothes washing, bathing and livestock washing were observed, contributing to increased coliform levels and potential contamination.

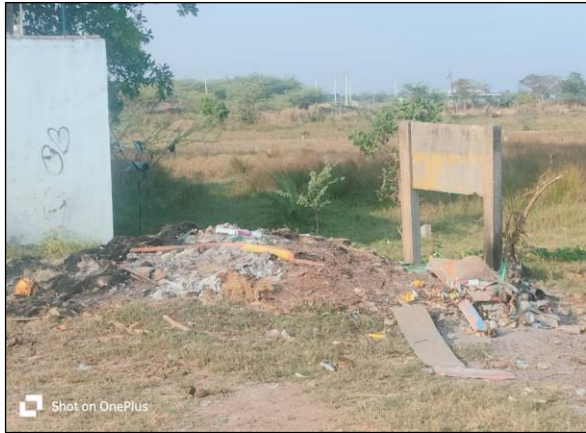
**Figure 4.1: Photographs of Open Burning near industrial areas**

| Component | Measures Suggested | Implementation Status |
|---|---|---|
| | Source collection of Solid Waste and avoidance of open burning in surrounding villages. | <b>Implemented</b> – No open burning was observed in the immediate vicinity of the lake. However, instances of burning were noticed upstream (Figure 4.1) near certain industrial areas; this may pose a potential risk to water quality during monsoon runoff. |

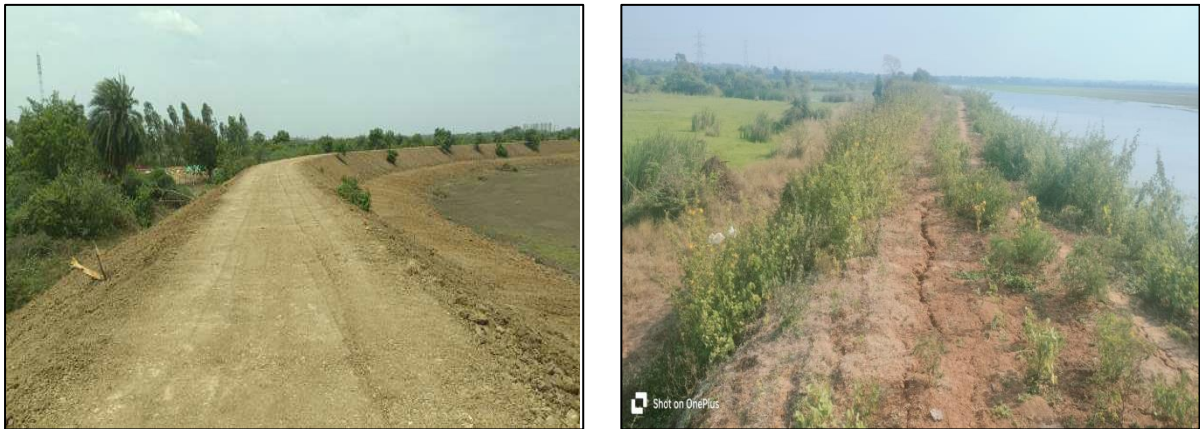
**Figure 4.3: Photographs of the bund after restoration and its present status**

Cracks were observed along the lake bund, which may lead to seepage and compromise structural stability. The bund, which also serves as a pathway, is covered with weeds, resulting in reduced accessibility and usability. This affects the intended function of the restored bund as a safe and functional access route for the locals. Photographs of the bund after restoration and its present status are shown in Figure 4.3.

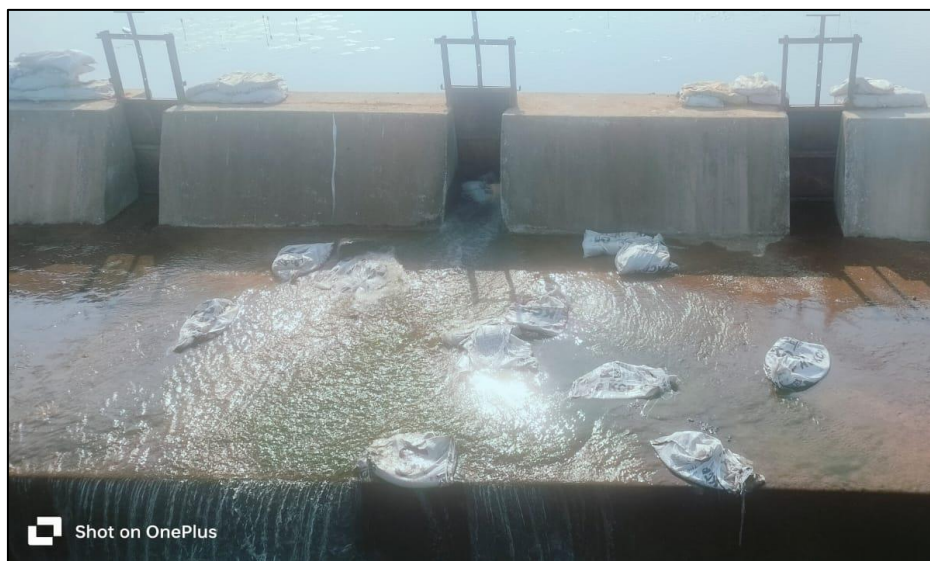
**Figure 4.4: Photograph showing use of sand filled bags to regulate water flow**

Sluice gates were found to be rusted and not fully functional. Use of sand filled bags (Figure 4.4) for regulating water flow was observed.
