## ENVIRONMENTAL IMPACT ASSESSMENT

# Restoration of the Masaorambhu Stream

*Desilting & Reconstruction of Seven Check Dams*

Masaorambhu Stream,  
Siruvani, Coimbatore

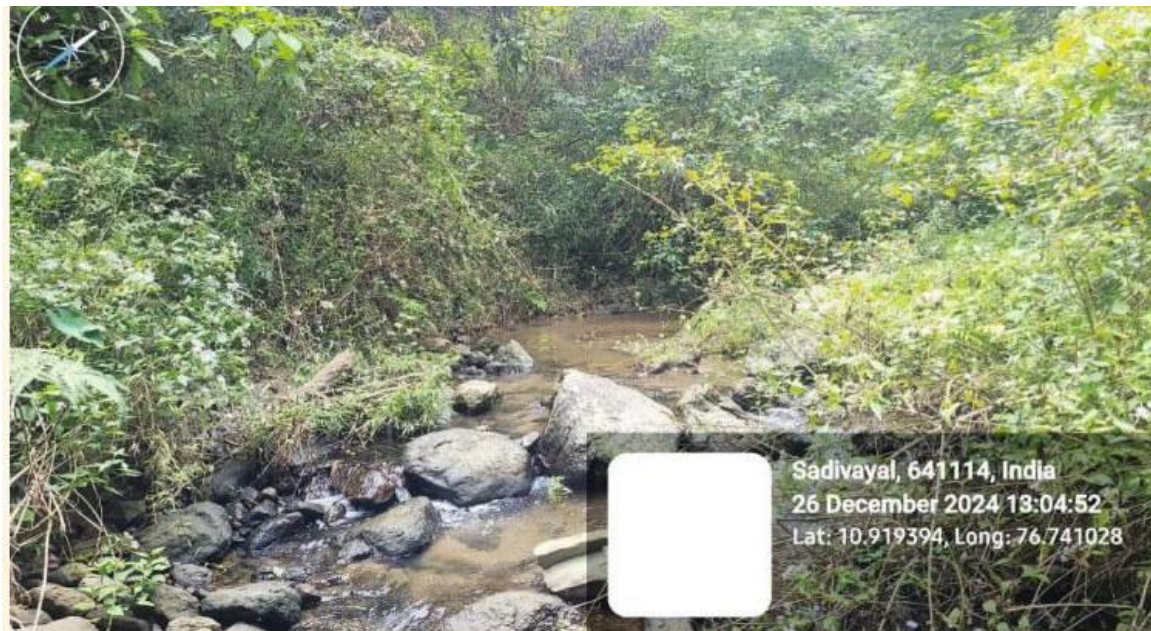
*Inlet of the Masaorambhu Stream at the border of Reserve Forest and Patta land (Dec 2024)*

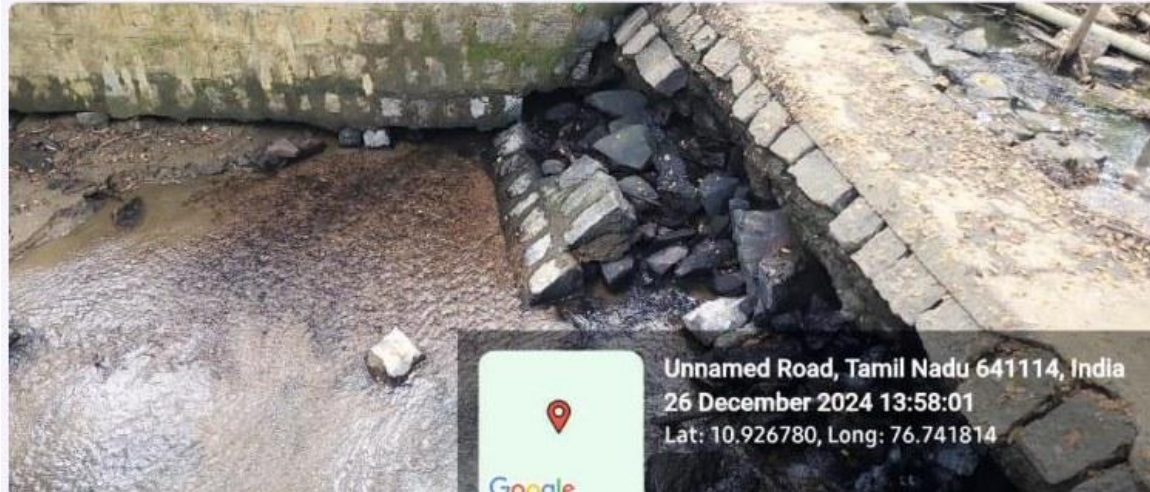
*Severe damage to a weir wall leading to water seepage — baseline condition (Dec 2024)*

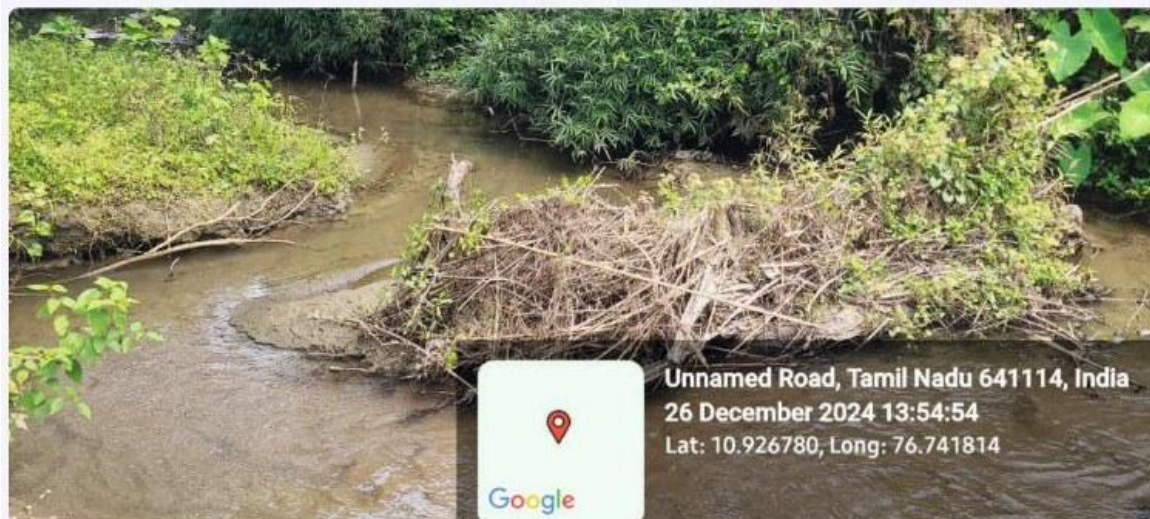
*Severe silt formation and vegetation obstructing water flow — pre-intervention*

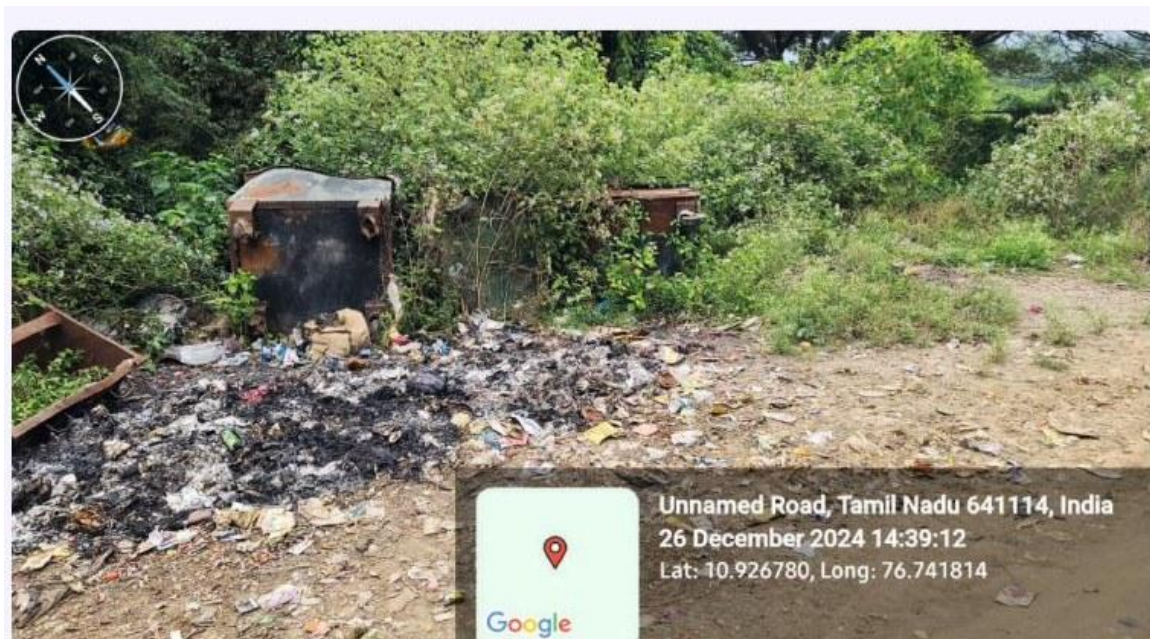
During field inspections, localised dumping of solid waste was observed in areas near Check Dam 6. The waste consisted primarily of household refuse and construction debris disposed along the stream banks. Improper disposal of waste in riparian areas poses several environmental risks, including potential contamination of surface water during rainfall runoff, obstruction of stream flow and drainage pathways, and degradation of habitat conditions for aquatic and riparian species.

*Waste dumping into the stream and bunds by community near Check Dam #6*

Panchayat has taken actions to address this by introducing daily home collection of waste by green friends. This is making a change in the waste dumping practices alongside the Check dam/ stream

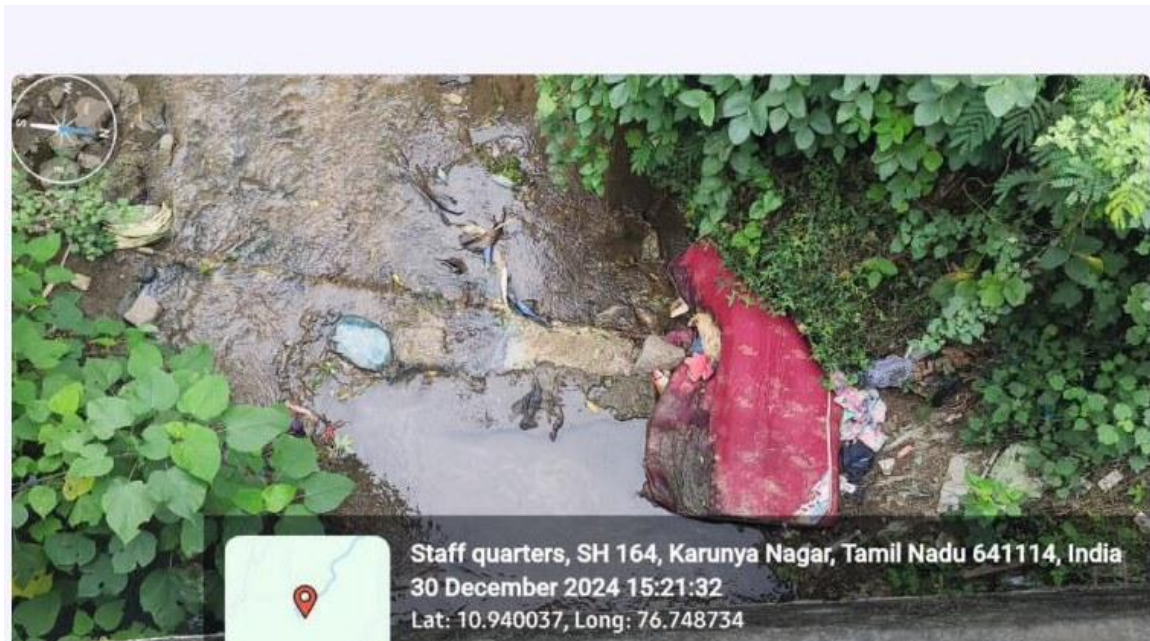
Another environmental concern identified during the assessment is the presence of untreated or partially treated wastewater entering the stream near the Siruvani Road section. Sewage inflow into natural water bodies can lead to nutrient enrichment and eutrophication, reduction in dissolved oxygen levels, and degradation of water quality for downstream users. While the current impact on water quality appears limited due to dilution during rainfall events, continued discharge may gradually affect ecological health. Installation of appropriate sewage treatment systems would significantly reduce this risk.

*Sewage discharge observed near the Siruvani road section*

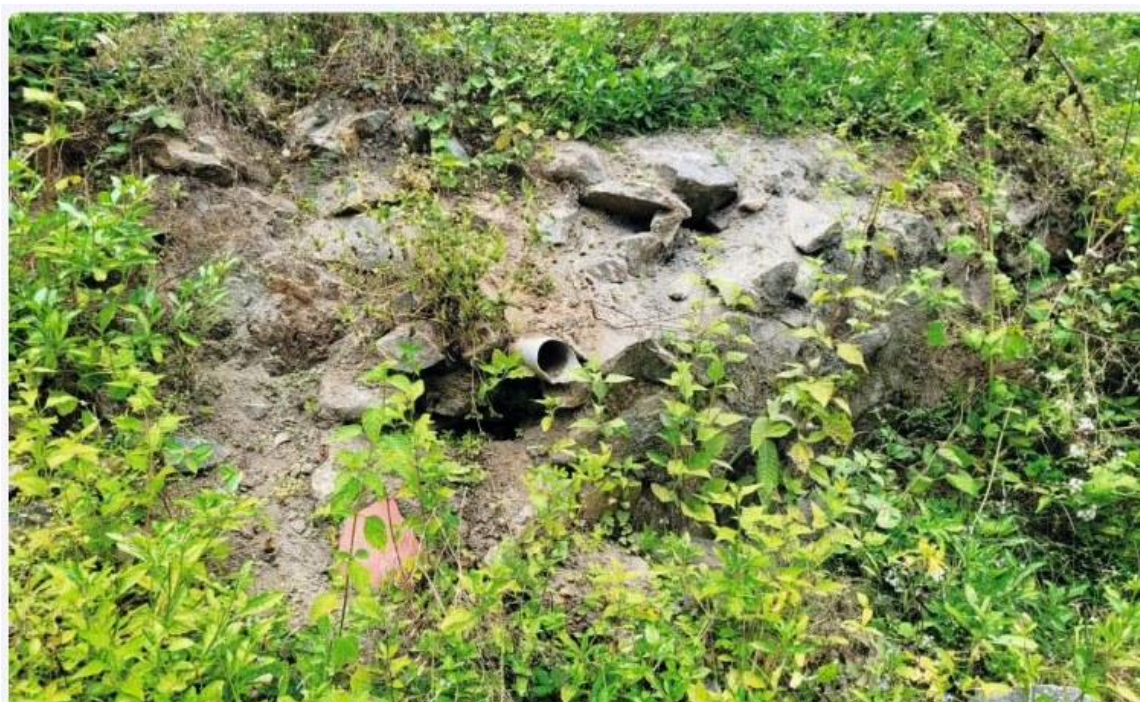
The assessment noted the potential discharge of wastewater from nearby educational and institutional campuses located within the broader watershed. While these institutions maintain internal wastewater management systems, ensuring that only properly treated water is released into the natural drainage system is essential to prevent contamination of the stream. Institutional collaboration and environmental compliance will therefore play an important role in safeguarding the restored stream ecosystem.

*Outlet pipe from a nearby institutional campus discharging into the stream*

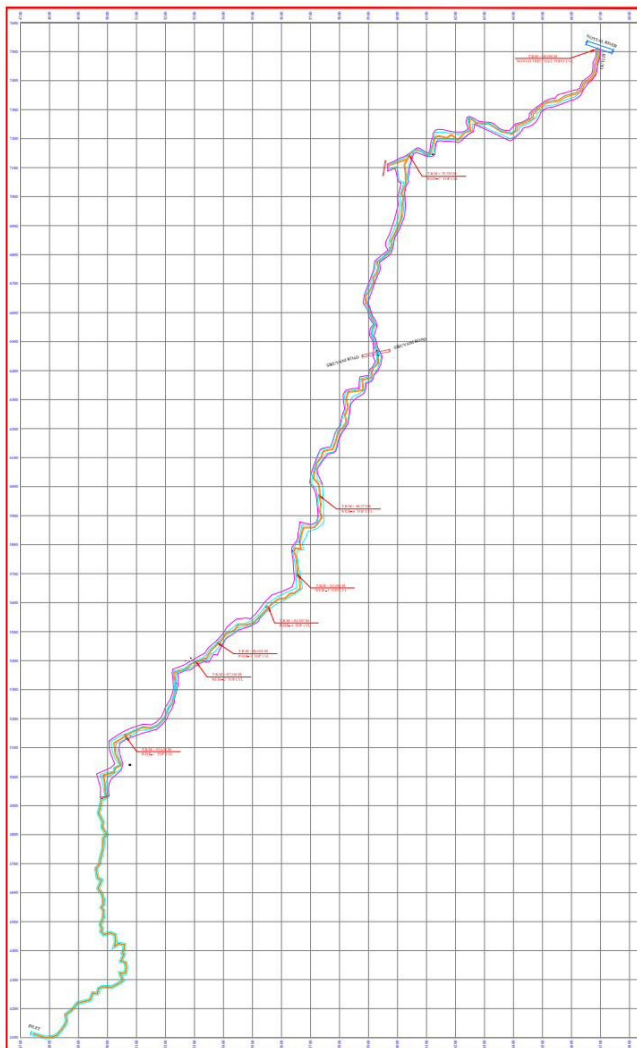
B E F O R E D E S I L T I N G

Stream profile prior to intervention — Dec 2024

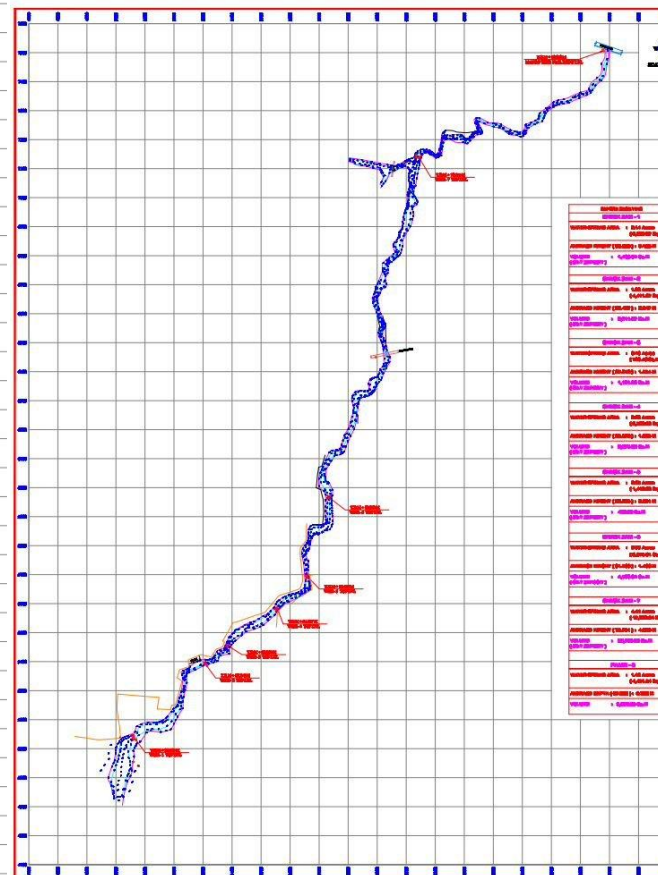
A F T E R D E S I L T I N G

Stream profile post-restoration — 2025/2026

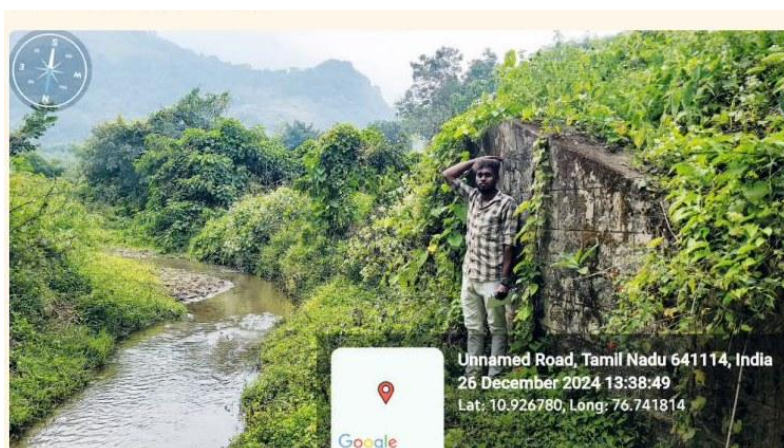
Check Dam #1 — only wing walls and no weir wall at baseline (Dec 2024). Water flow width of just 5–8 feet and no storage area.

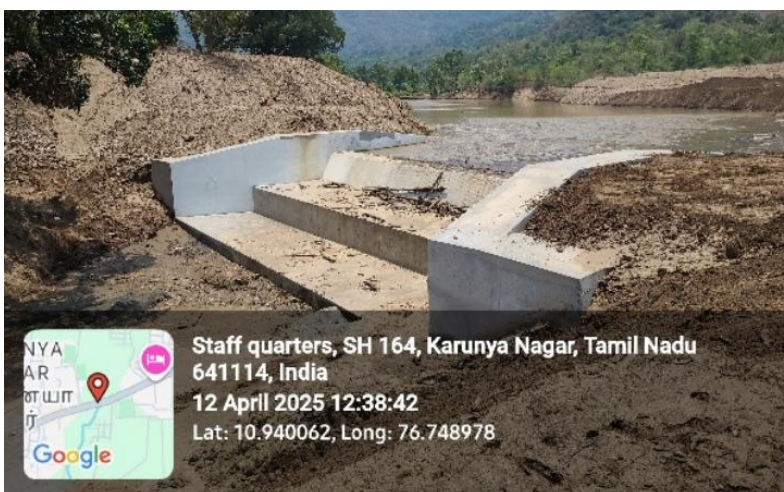
Check dam #1 with reconstructed Check dam and huge water storage area

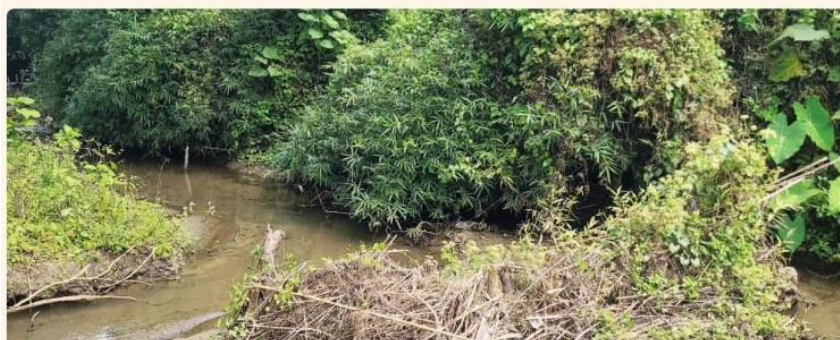
| Check Dam | Baseline Condition | Key Issue | Proposed Action |
|---|---|---|---|
| Dam #2 | Completely damaged, no weir/side walls | Incomplete structure | Desilting & reinforcement |

Check Dam #2 — only wing walls and no weir wall at baseline.

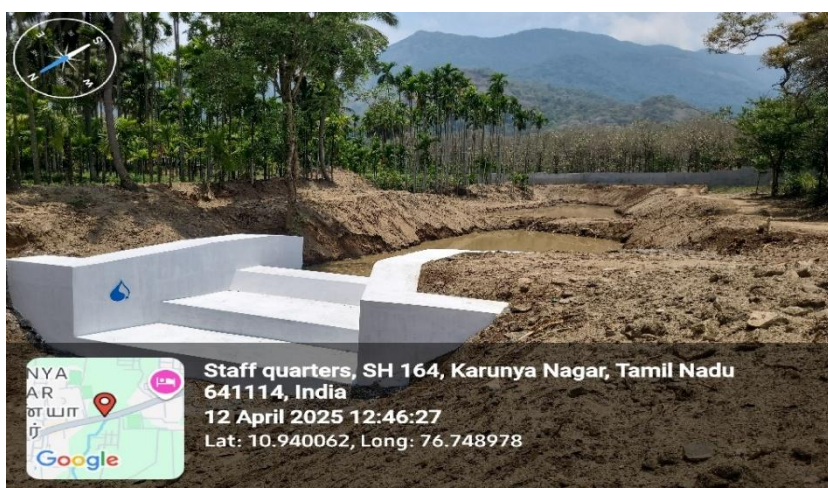
Reconstructed Check dam #2 and desilting is complete

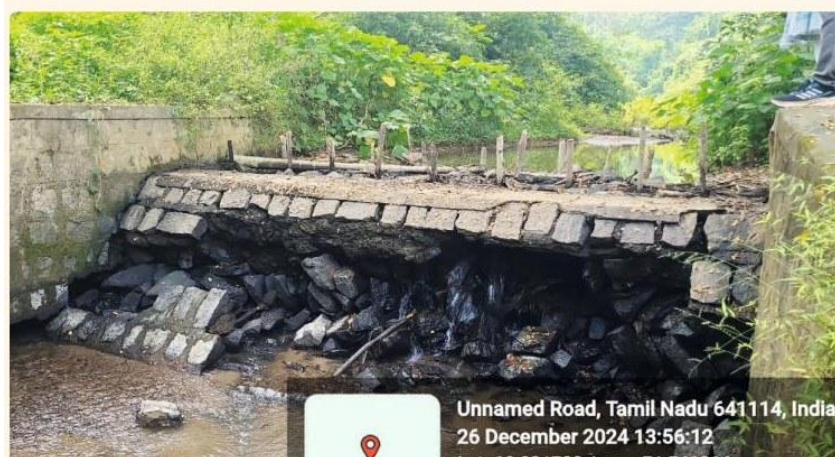
| Check Dam | Baseline Condition | Key Issue | Proposed Action |
|---|---|---|---|
| Dam #3 | Severe silt, cracks & seepage | Reduced water retention | Reconstruction needed |

Check Dam #3 — severe silt accumulation, cracks and seepage in the weir; almost inaccessible at baseline.

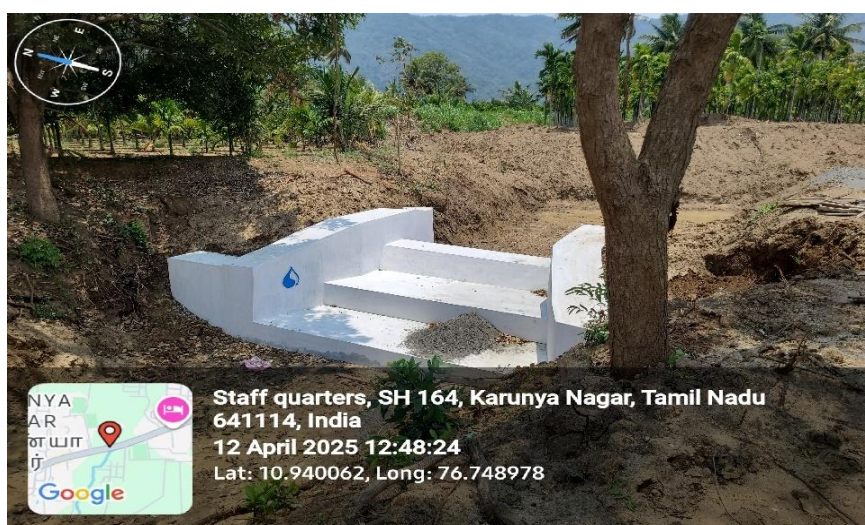
Check dam #3 after reconstruction and desilting

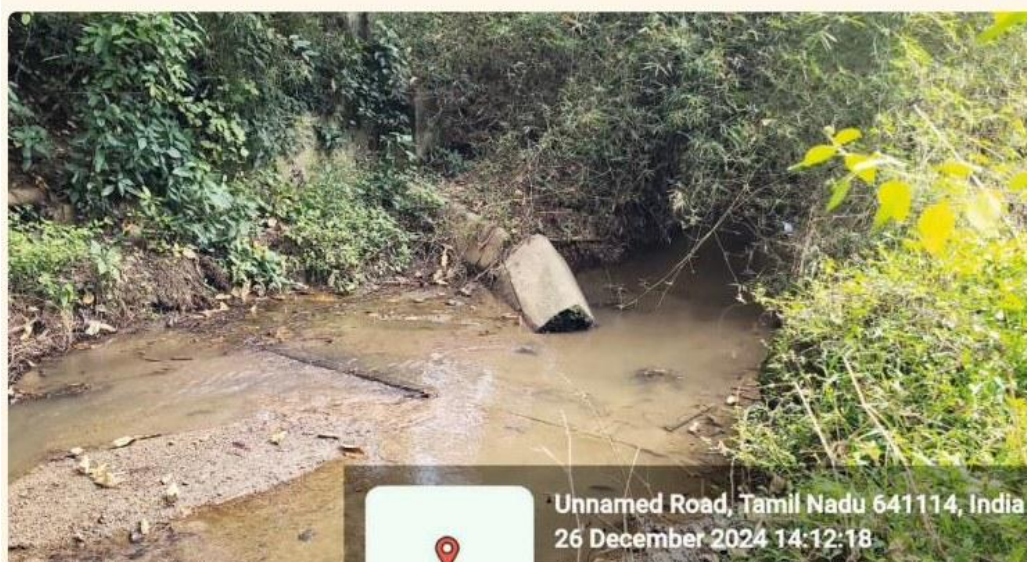
| Check Dam | Baseline Condition | Key Issue | Proposed Action |
|---|---|---|---|
| Dam #4 | Only wing walls, half weir missing | Incomplete structure | Reconstruction needed |

Check Dam #4 — only wing walls and no weir wall at baseline.

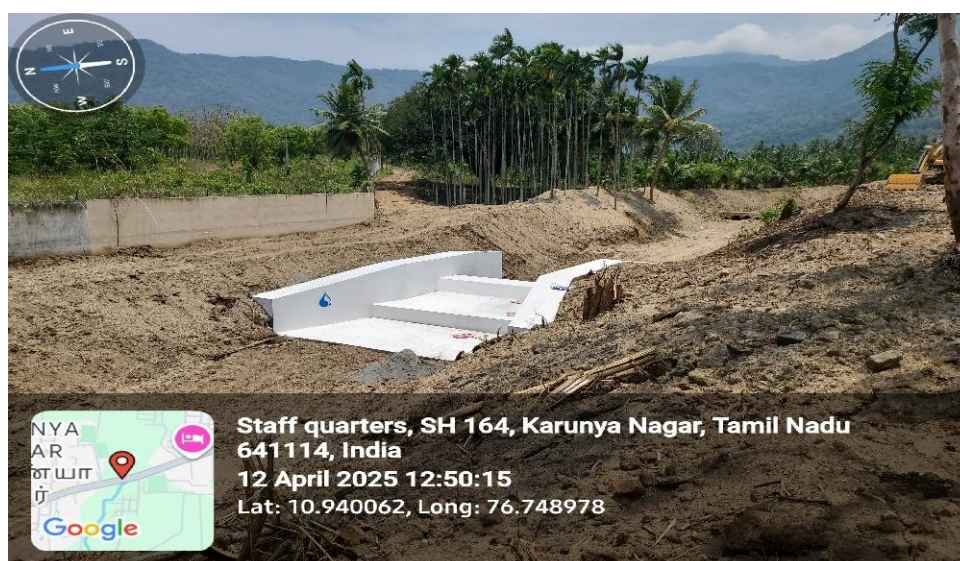
Check dam #4 after reconstruction and desilting

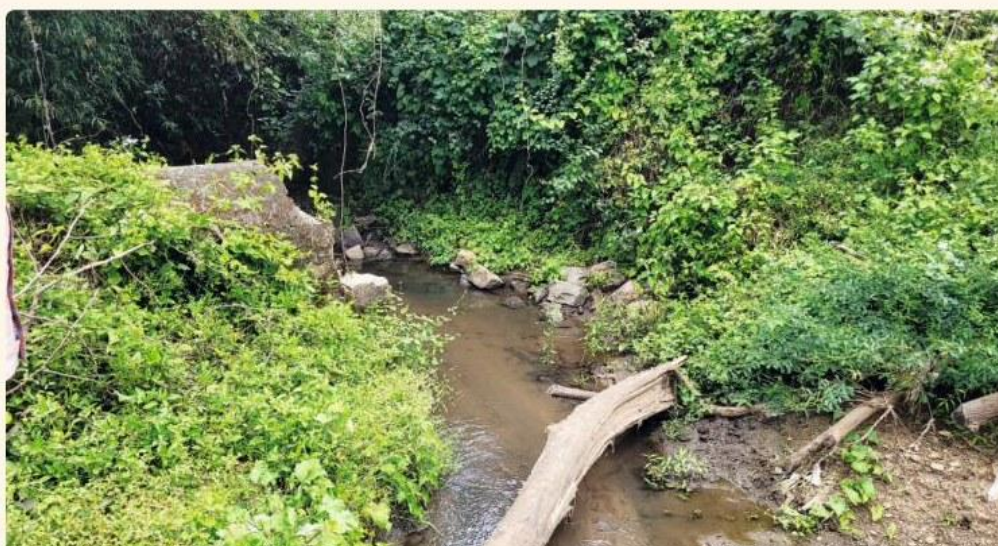
| Check Dam | Baseline Condition | Key Issue | Proposed Action |
|---|---|---|---|
| Dam #5 | Only wing walls, weir missing | Incomplete structure | Reconstruction needed |

Check Dam #5 — only wing walls and no weir wall at baseline.

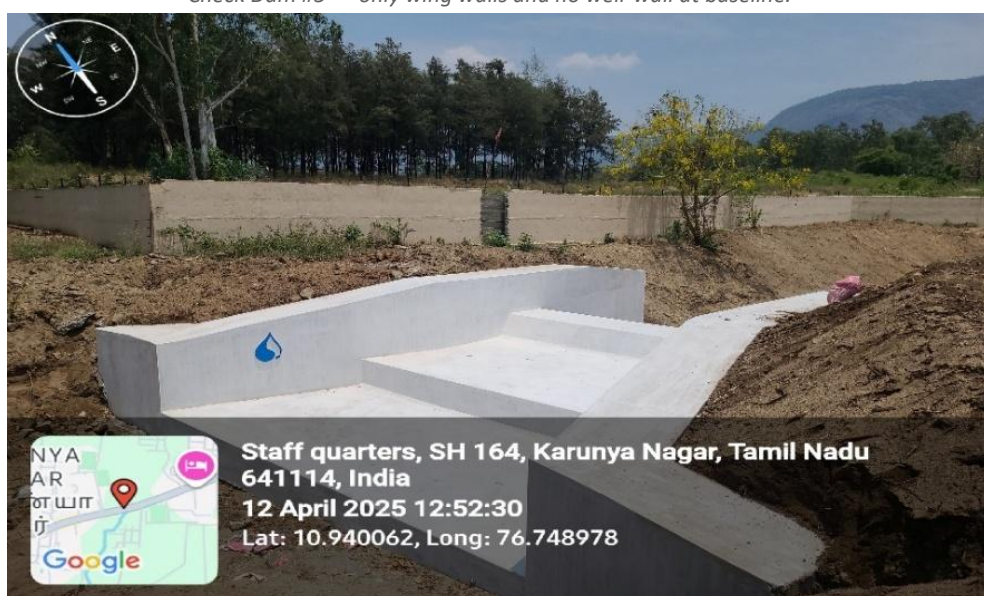
Check dam #5 after reconstruction and desilting

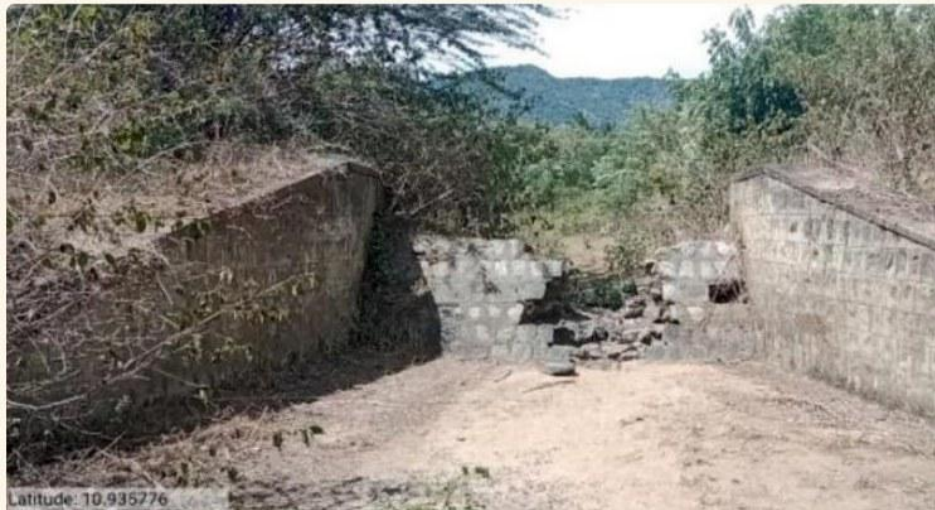
| Check Dam | Baseline Condition | Key Issue | Proposed Action |
|---|---|---|---|
| Dam #6 | Severe silt, cracks & seepage | Incomplete structure | Desilting & reinforcement |

Check Dam #6 — only wing walls and severe damage to weir wall at baseline.

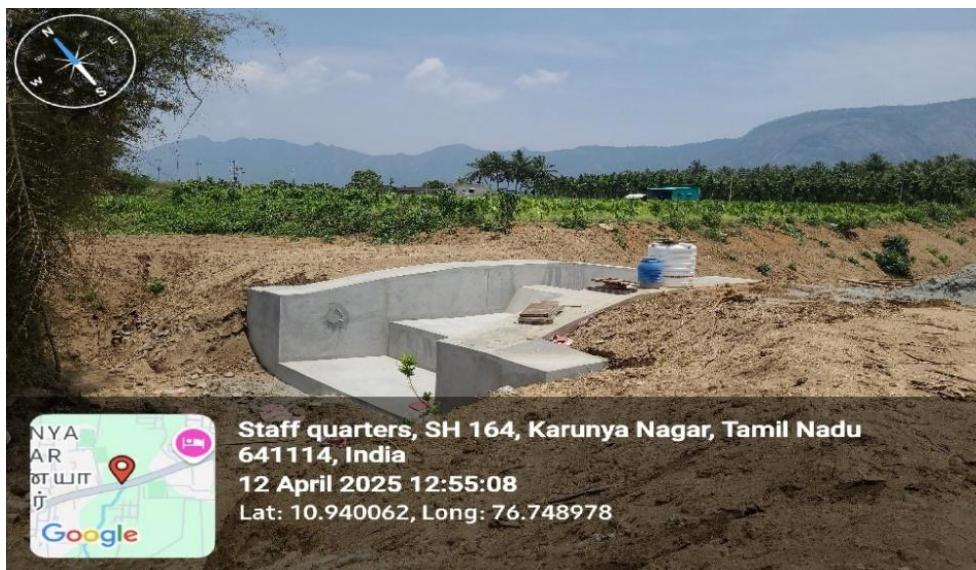
Check dam #6 after reconstruction and desilting

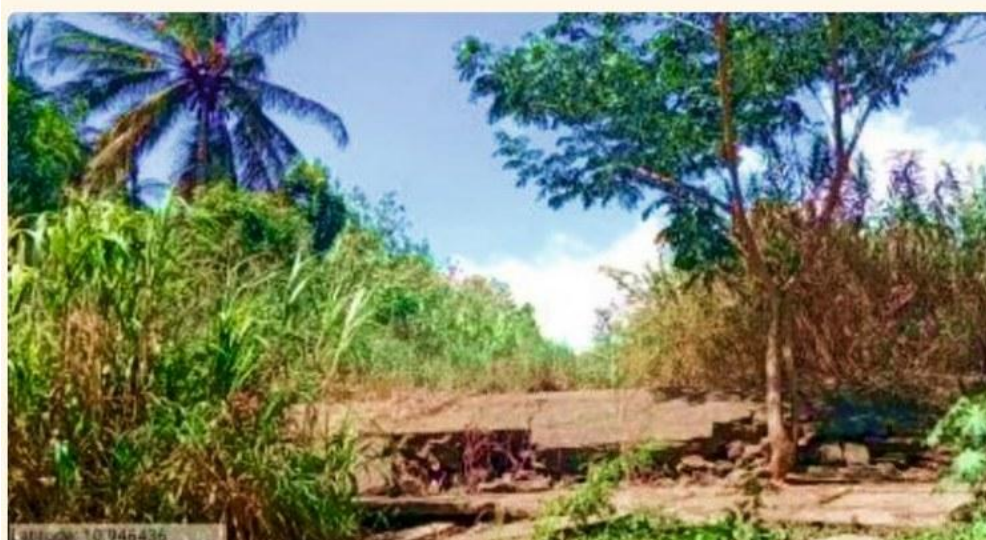
| Check Dam | Baseline Condition | Key Issue | Proposed Action |
|---|---|---|---|
| Dam #7 | Severe damage to wing & weir walls | Incomplete structure | Reconstruction needed |

Check Dam #7 — no wing walls and no weir wall at baseline; the largest silt removal on the corridor.
