# Environmental Audit Report

## Post Restoration of Gunduperumbedu Lake

May 2026

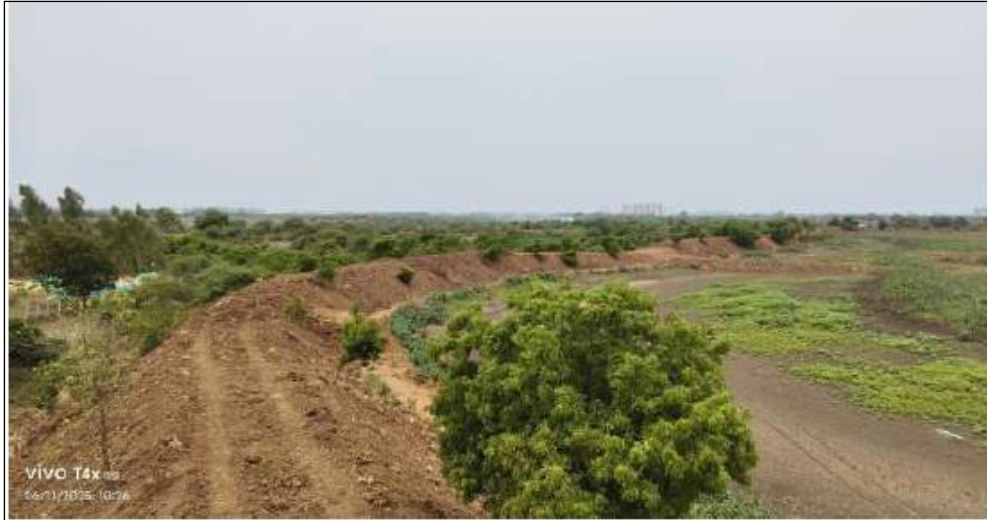
**Figure 2.4 a): Bund formed using excavated soil**

**Formation of Bund:** Utilizing the excavated soil, strengthening of the bund over a length of 2,871 m has been done. As per the norms of the Water Resources Department (WRD), the soil deposition along the bund has been done with a thickness ranging from 1.3 to 2.0 m.

**Compaction of Bund:** Compaction work has been carried out using a vibratory roller at every 0.3 m layer. Photographs of the bund before, during and after restoration are given in Figure 2.4.

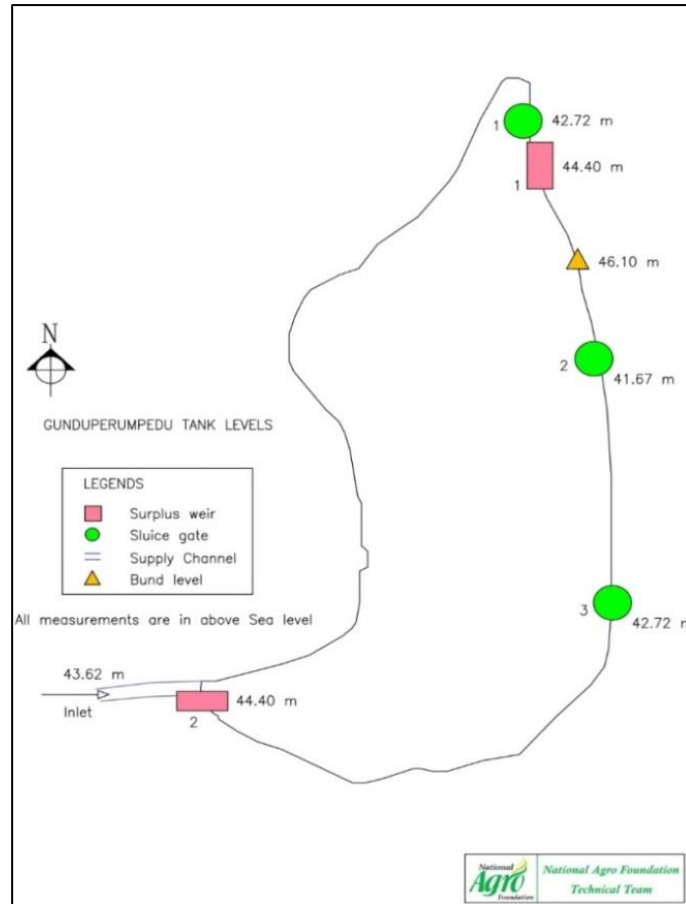
Figure 2.6: Layout showing the tank structures proposed for renovation

The lake restoration activities as per the DPR include re-construction of the surplus weir and three sluice gates to regulate water level and control outflow to the downstream lakes. The layout showing the tank structures renovated is shown in Figure 2.6.

An RCC walkway at the northern end of the lake, which provides access to the sluice gates, was found to be damaged requiring urgent attention. The surplus weir and the walkway have been renovated, thereby restoring access to the lake and the sluice gates. De-weeding, de-silting and removal of invasive plant species have also been carried out. Additionally, two mud mounds have been built in the lake, probably to enhance the aesthetic value and ecological features. No appreciable benefits of these structures were visible during the field study.

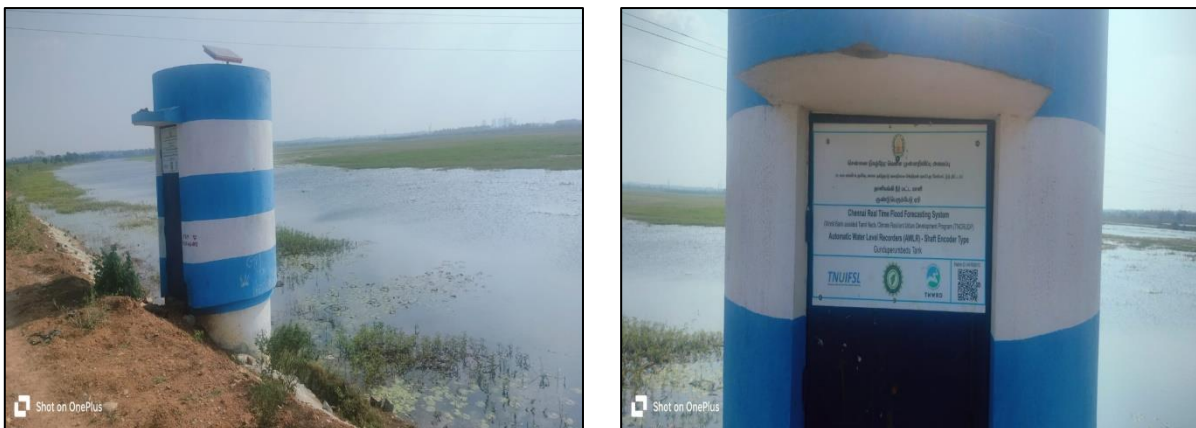
**Figure 2.8: Automatic water level recorder installed at the lake**

An automatic water level recorder (Figure 2.8) has been installed by the Revenue Administration and Disaster Management Department, Water Resources Department of Tamil Nadu to continuously monitor fluctuations of water level in the lake. This system enables accurate and real-time recording of water levels, facilitating effective management of inflow and outflow through the sluice gates and surplus weir. The recorded data also assists in flood monitoring and long-term assessment of the lake's hydrological performance.

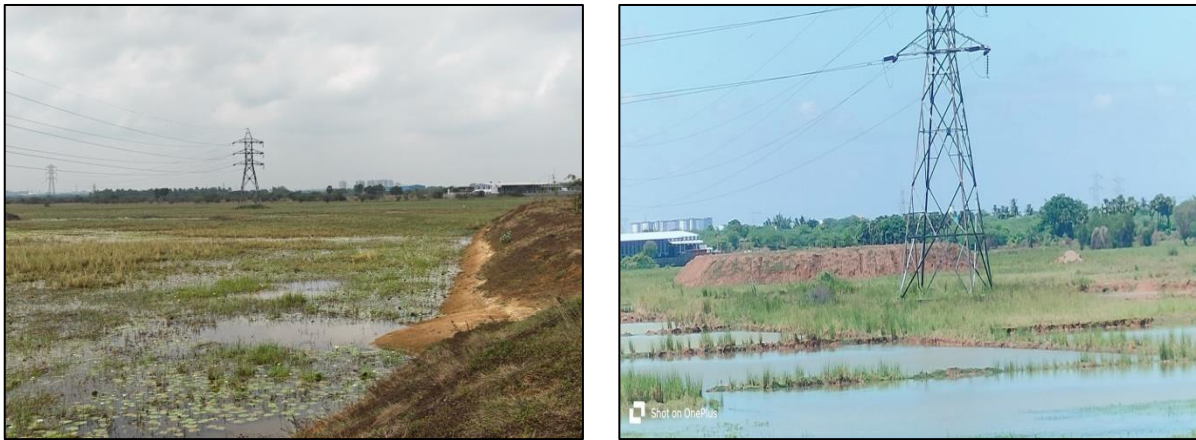
**Figure 3.5: Mud mounds formed in the lake**

A total of 87 bird species was recorded in and around the lake during field study. These include resident species, local seasonal migrants and winter migratory visitors. The lists of birds sighted are listed in Table 2 of Annexure VI. The two mud mounds (150 m × 50 m × 3.4 m) created during de-silting have become raised zones within the lake (Figure 3.5). These may gradually evolve into microhabitats and serve as roosting sites for birds, as well as basking areas for reptiles like Bengal Monitor Lizard, Indian Flap-shelled Turtle, Garden Lizard and several skink species.

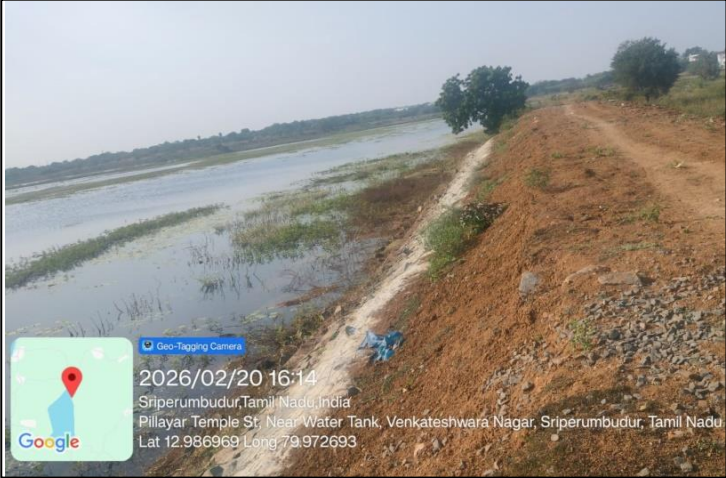
Adoption of safe disposal methods for removed weeds such as composting or mulching to prevent odour issues and emissions	<b>Implemented</b> – Unsafe disposal of weeds and removed shrubs were not evident during the site visit.
<b>Biological Environment</b>	Endemic vegetation shall be preserved as far as possible; prioritizing the protection of native species over the removal of invasive ones.	<b>Implemented</b> – Invasive species have been removed while retaining native vegetation within the lake and surrounding areas.

<p><b>Figure 4.2: Photographs of native trees retained along the bund</b></p>
	<p>Native plant species shall be reintroduced for enhancing habitat suitability to support local wildlife.</p>	<p><b>Partially Implemented</b> – Native plantation has been undertaken; further improvement may be planned considering the low survival rate of planted saplings. A total of 1,006 saplings were planted, of which 428 have survived indicating a survival rate of 43%.</p>
	<p>Creation of habitat features such as mud mounds.</p>	<p><b>Partially Implemented</b> – Mud mounds measuring 150 m length, 50 m Breadth and 3.4 m depth have been created to providing suitable nesting and roosting habitats for bird species. Additional strengthening of plantation activities will enhance habitat quality and overall ecological benefits.</p>
	<p>Conservation of nearly threatened species <i>Terminalia arjuna</i> (Arjuna Tree) to be carried out.</p>	<p><b>Implemented</b> – A total of 210 <i>Terminalia arjuna</i> have been planted as part of the restoration activities</p>
