# Environmental Audit Report

## Post Restoration of Gunduperumbedu Lake

July 2026

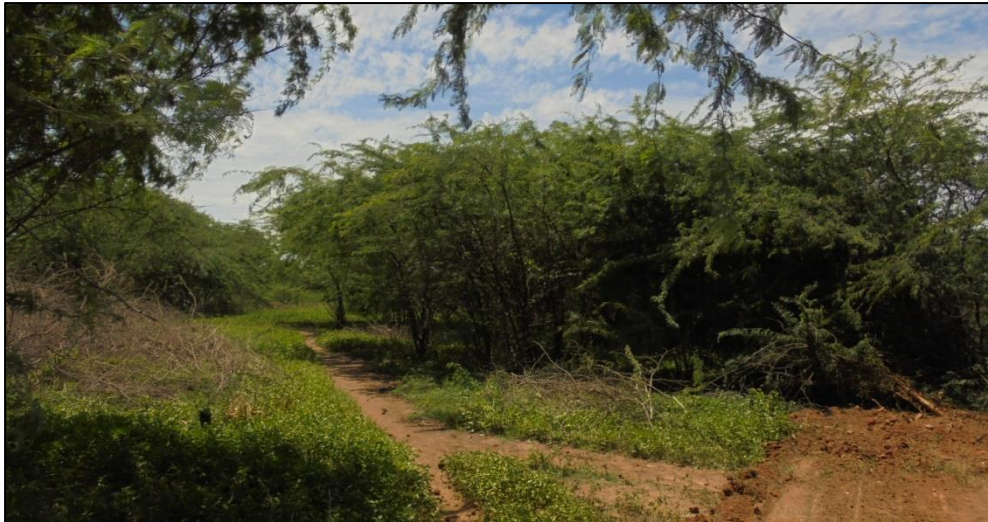
**Figure 2.4 a): Bund before restoration**

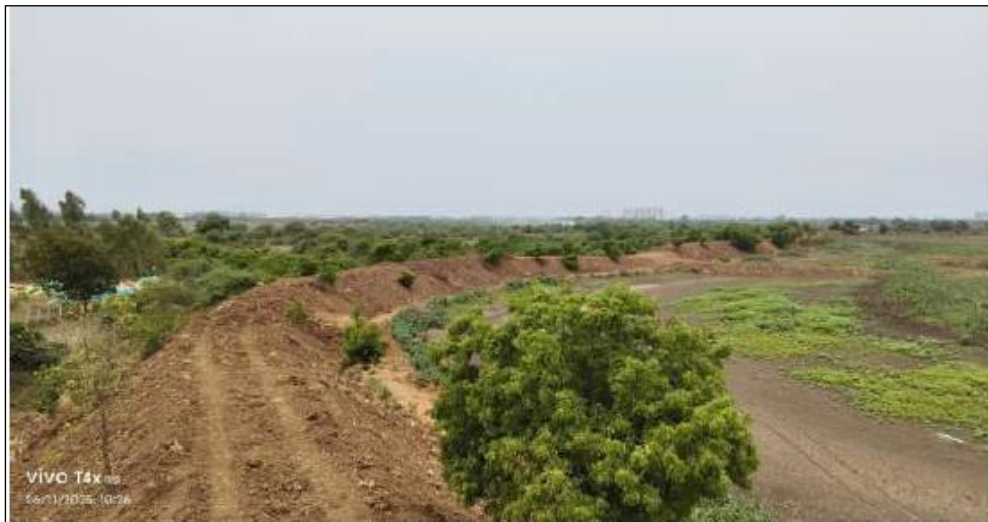
**Figure 2.4 b): Post restoration Bund formed using excavated soil**

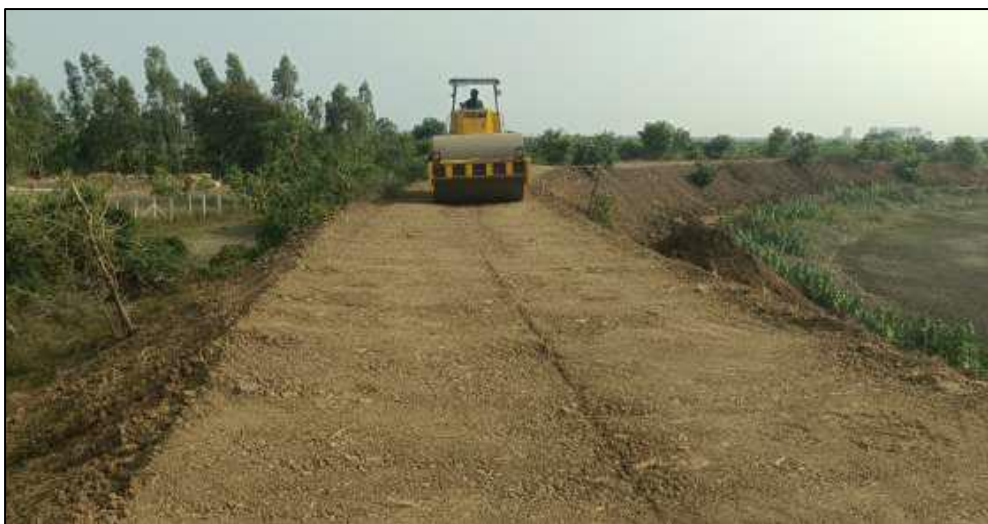
**Figure 2.4 c): Consolidation of the Bund in progress**

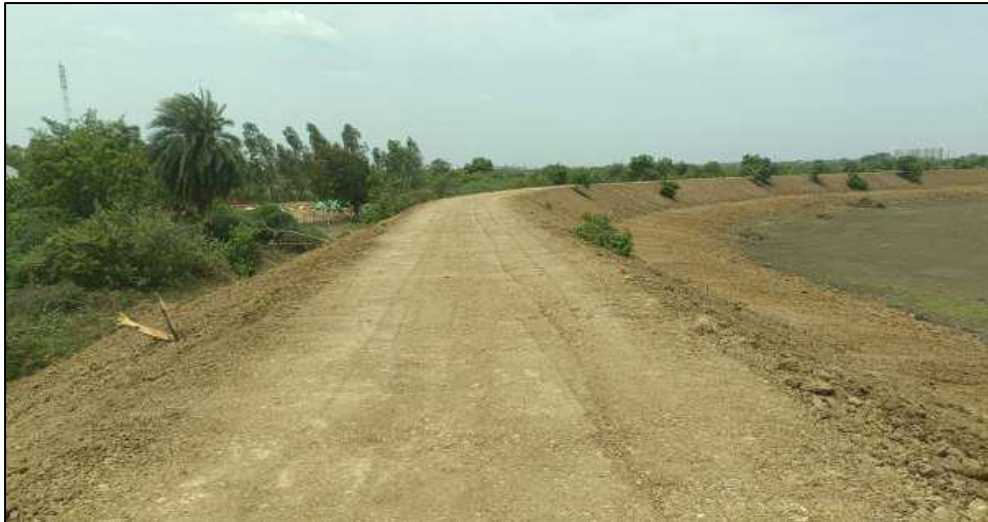
**Figure 2.4 d): Bund after restoration**
