## ENVIRONMENTAL IMPACT ASSESSMENT

# Restoration of the Masaorambhu Stream

*Desilting & Reconstruction of Seven Check Dams*

Masaorambhu Stream,  
Siruvani, Coimbatore

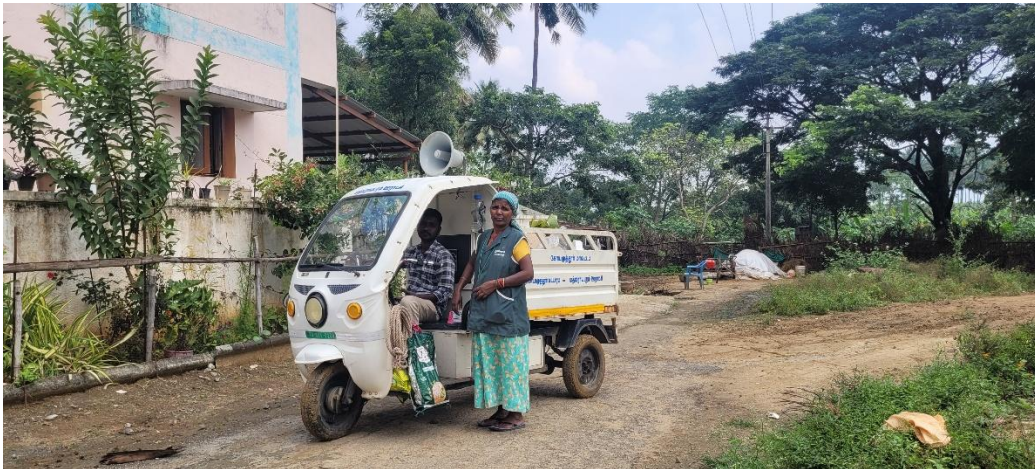
*Waste dumping into the stream and bunds by community near Check Dam #6*

Panchayat has taken actions to address this by introducing daily home collection of waste by green friends. This is making a change in the waste dumping practices alongside the Check dam/ stream
