# Environmental Audit Report

## Post Restoration of Gunduperumbedu Lake

July 2026

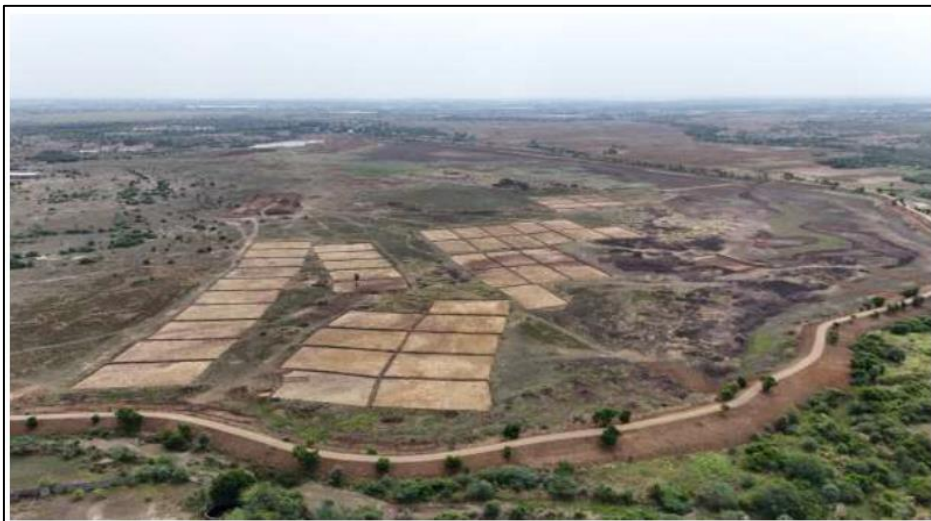
**2.2 c): Drone image of the lake after restoration**

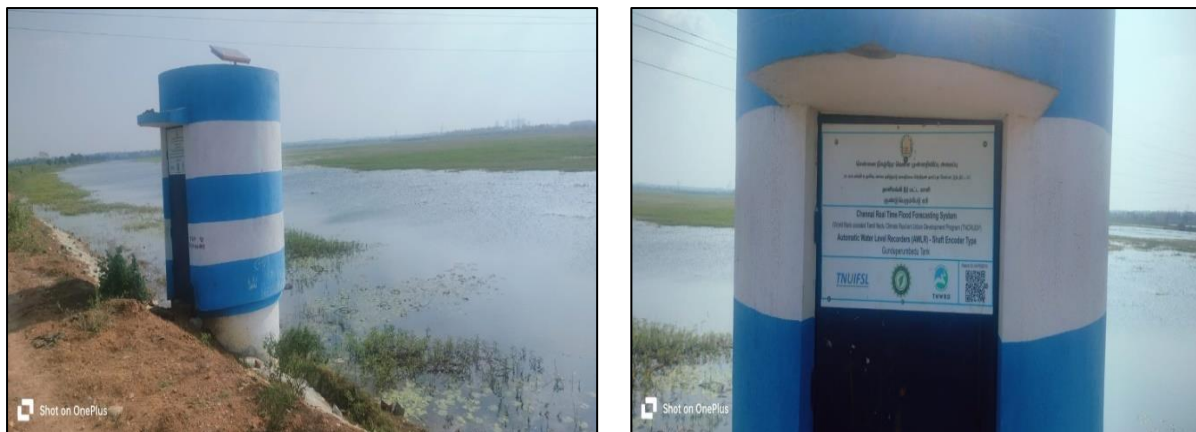
Renovation of the lake structures has improved the ability of the lake to regulate water level. The surplus weir enables safe discharge of excess water during and post heavy rainfall. The sluice gates facilitate controlled release of water to the agricultural fields (Ayacut area) and lakes downstream. Thus, the strengthened bund and renovated lake structures help manage runoff, reduce flood risk and help maintain the water level in the lake. An automatic water level recorder (Figure 2.8) has been installed by the Revenue Administration and Disaster Management Department, Water Resources Department, Tamil Nadu to continuously monitor water level in the lake.

**Figure 2.8: Automatic water level recorder installed at the lake**

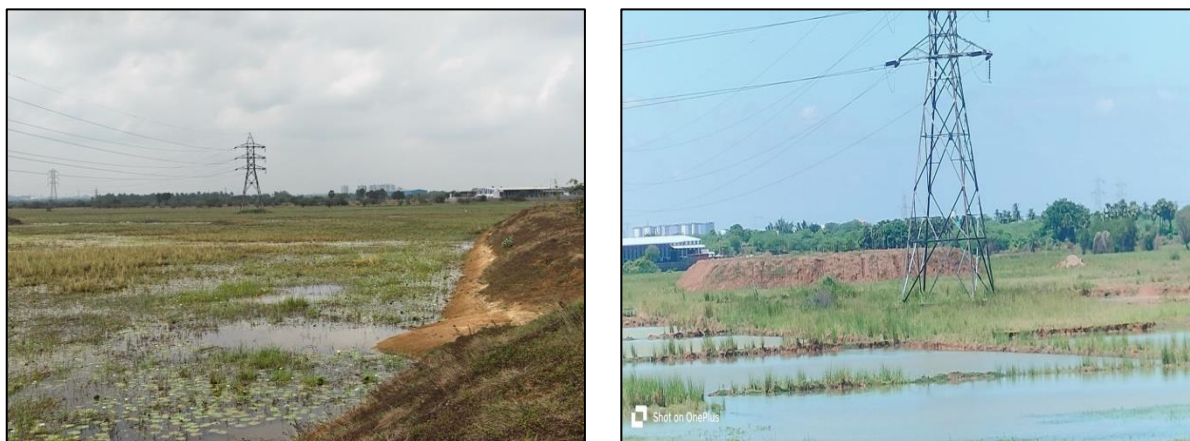
visitors. The lists of birds sighted are listed in Table 2 of Annexure VI. The two mud mounds (150 m × 50 m × 3.4 m) created during de-silting have become raised zones within the lake (Figure 3.7). These may gradually evolve into microhabitats and serve as roosting sites for birds, as well as basking areas for reptiles like Bengal Monitor Lizard, Indian Flap-shelled Turtle, Garden Lizard and several skink species.

**Figure 3.7: Mud mounds created in the lake**

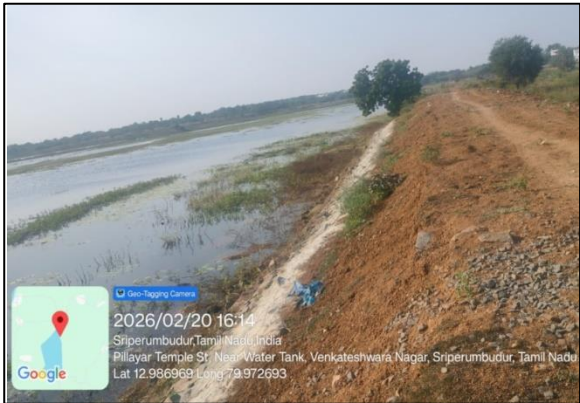
| <b>Biological Environment</b> | Endemic vegetation shall be preserved as far as possible; prioritizing the protection of native species over the removal of invasive ones. | <b>Implemented</b> - Invasive species have been removed while retaining native vegetation within the lake and surrounding areas. |

| | | <p><b>Figure 4.2: Photographs of native trees retained along the bund</b></p> |
